**Report of the Investigation**  
**of a man overboard fatality from**  
**the Etchells 22 keelboat**  
***WAHOO***  
**off Yarmouth, Isle of Wight**  
**on 14 May 1999**

File: 1/10/191

Marine Accident Investigation Branch  
Carlton House  
Carlton Place  
Southampton

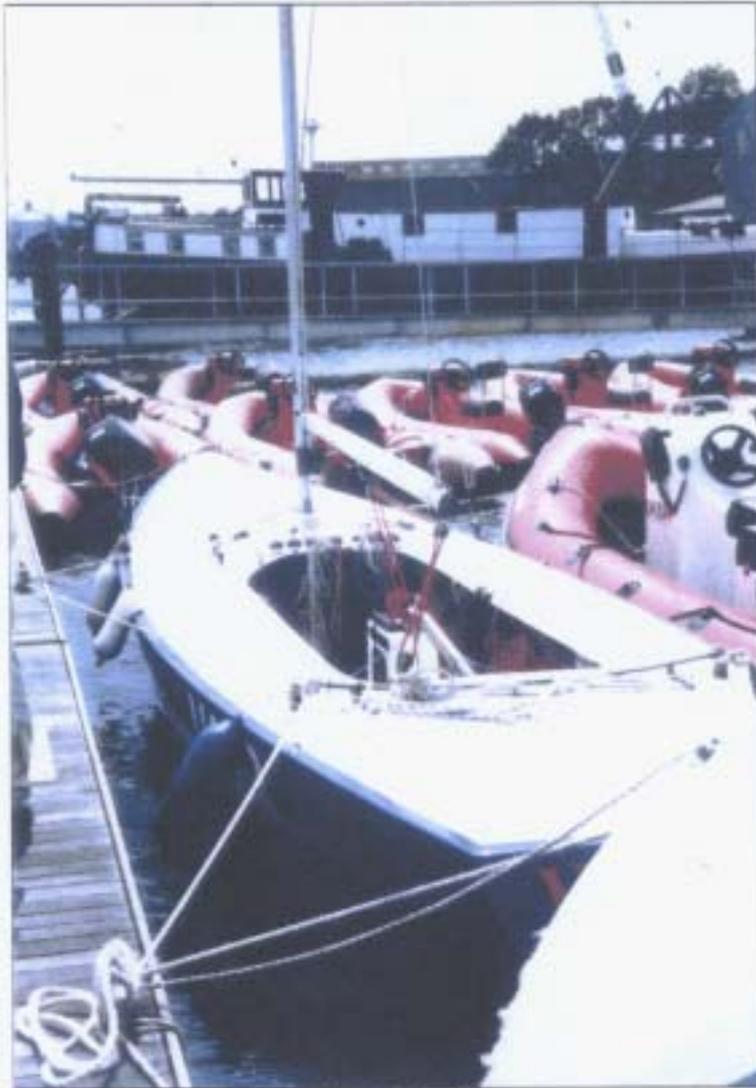
Etheells 22 Keelboat

The Etchells 22 boat is primarily a racing keelboat which is built of glass reinforced plastic (GRP) and designed for performance. She is Bermudan rigged and carries a large sail area of 27m<sup>2</sup>. She is a day boat, there is no cabin. She is designed for a crew of two or three who stand inside, or perch on the sides of the cockpit (**Photograph**) while sailing. The boom is carried low to maximise the sail area. Movement within the cockpit is hindered by a central mounting, to which the main sheets and other cordage are led. Weight appears to be kept to a minimum and there are no safety rails fitted to the boat. She has a freeboard of about 0.8m when upright.

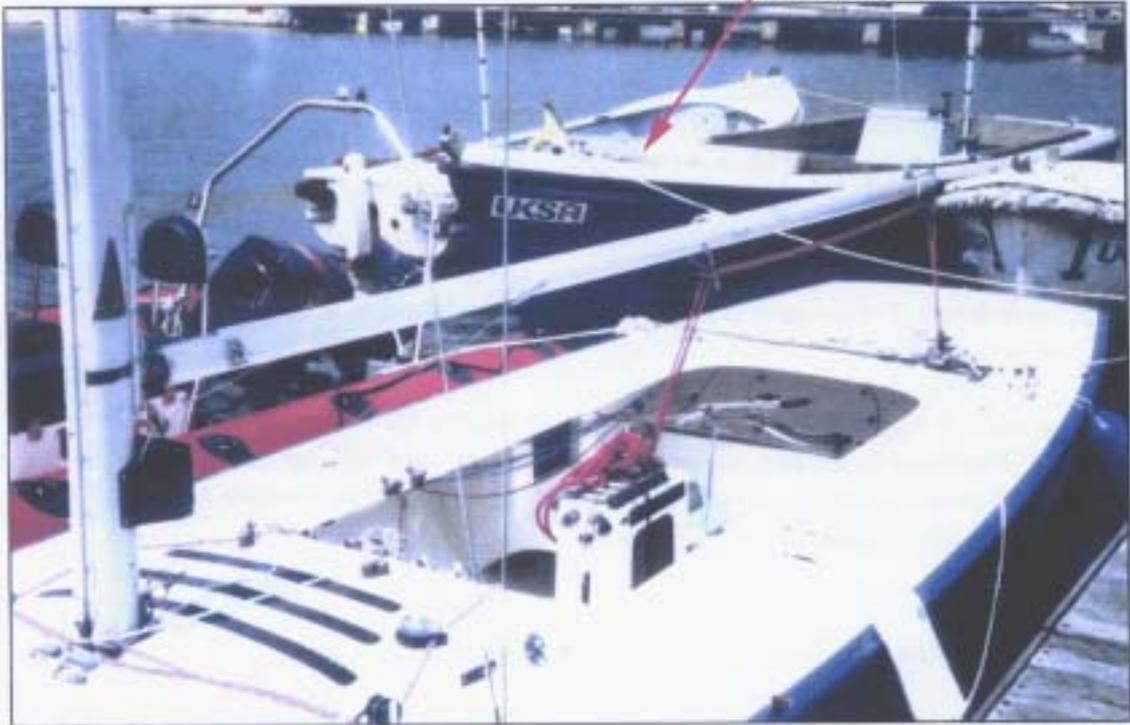
The safety boat

The Duver safety boat is a 6m long GRP launch with an inboard diesel engine. She is an open boat with a freeboard of about 1m when upright.

Once in the water it was the task of the instructors to recover Mr Ekman to either the launch or the sailing boat. They tried to get him on board the launch but, even with his help initially, this proved impossible. After an estimated 4 minutes he became unconscious and the task was then to seek help and to assist him in the water until it arrived.

All the academy's displacement launches are now fitted with an overside ladder, and trials have been undertaken, and a training exercise developed focusing on the recovery of an unconscious person to an inflatable boat.

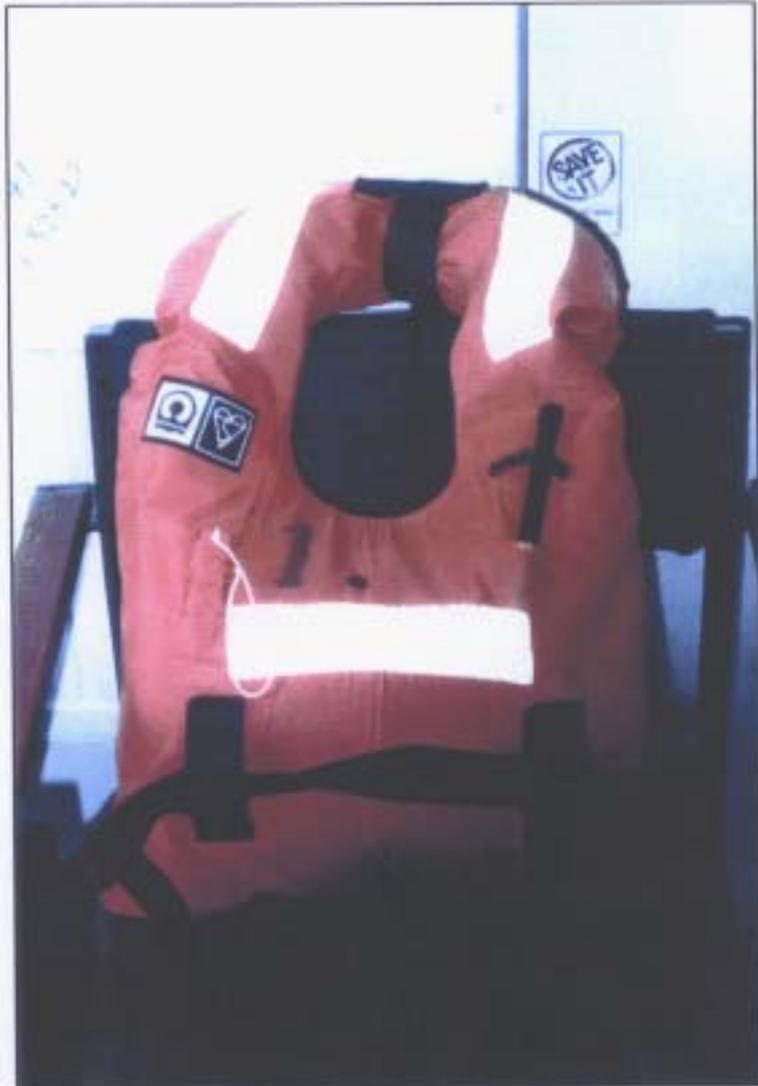
The lifejacket worn by Mr Ekman

Immediately, the instructors manoeuvred the launch alongside Mr Ekman and instructed him to inflate his lifejacket, which he did. He had been wearing a full 150N lifejacket, which consisted of part permanent foam buoyancy and part buoyancy, achieved by oral inflation. Mr Ekman at this time was conscious and lucid. He reported that he had not been injured.

When the boat gybed, Mr Ekman was tending the main sheets and perching to starboard of the central mounting. All the crew members were wearing buoyancy aids, as was required under the standing orders for keelboat sailing. Mr Ekman was wearing a full 150N lifejacket which had been bought the previous weekend as he could not fit into the academy's standard buoyancy aids. The lifejacket had a certain amount of permanent buoyancy (**Photograph**). He was also wearing a new set of yachting waterproofs and, beneath them, a fleece. His agility and mobility was additionally hindered by this equipment. When the boom swung across unexpectedly, he needed to duck low down or move forward of the central mounting. He did not have time to do either and the boom pushed him over the side.
