ORCV Internal Inquiry

14th August 2012

This Report provides the results of an Inquiry commissioned by the ORCV into the 2012 Melbourne to Port Fairy Yacht Race. During the race storm force winds caused damage to yachts, injuries to several crewmembers and the loss of the yacht Inception.

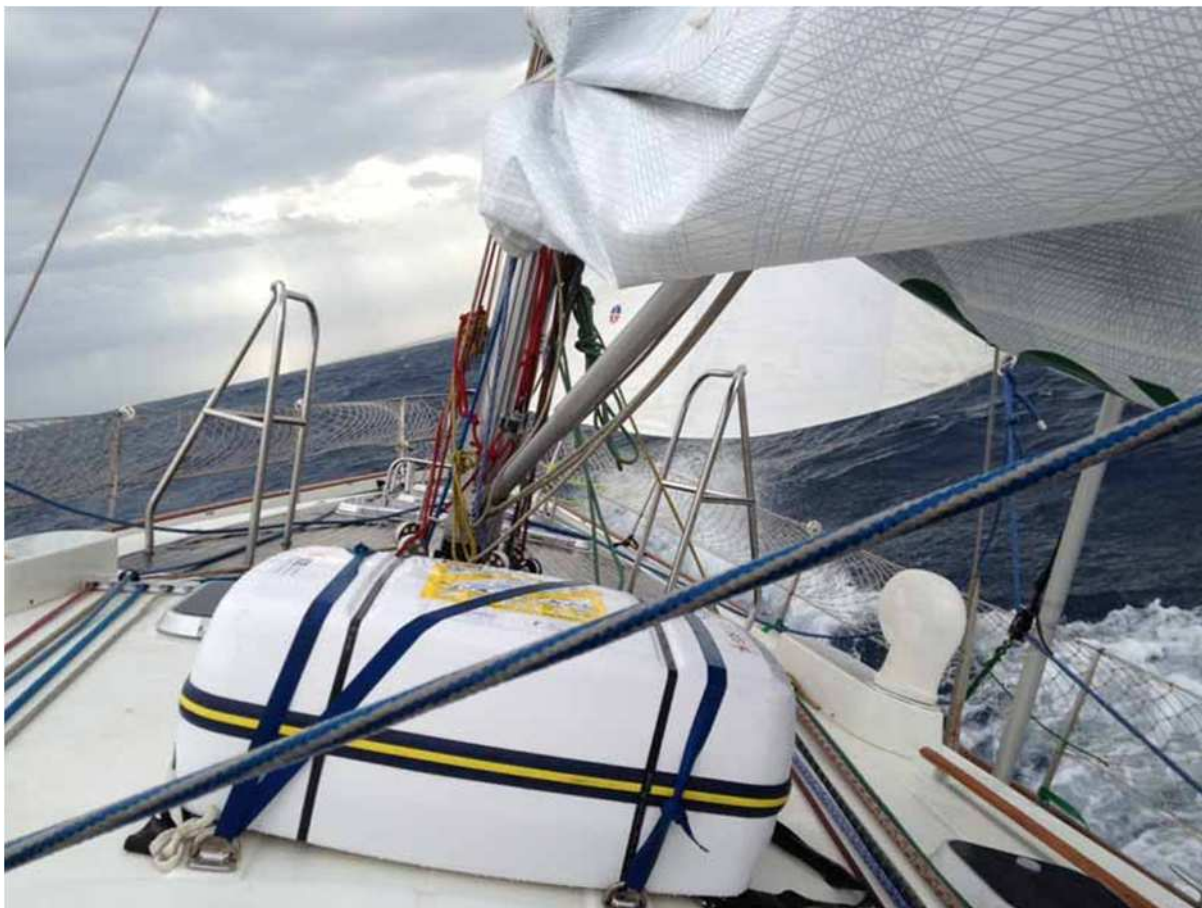
Figure 3 – Inception's Life Raft Stowage 6 April 2012

- 6.7.2 Figure 3 is a photograph of Inception's life raft stowage taken on the day of the incident, some hours before it was washed overboard. It met the 15 second safety requirement and passed the safety assessment – we suggest that it demonstratively failed the real world test on 6 April.

- 6.7.3 Accordingly, the stowage of the raft must be chosen with the possible worst case in mind. Calculations using data from a nearby wave riding buoy illustrate the quantum of forces involved in a wave driven by a 50 knot wind hitting a raft of the cross section of Inception's. The resultant 3,000 -4,000 Kg force is sensitive to the velocity of the wave at impact, however, the calculations serve to demonstrate the order of magnitude that could occur. In order to clear the guardrail as described by the crew, the raft was probably travelling at 70 ft/second (77 Km/hr) as it passed, airborne between the two crewmembers in the cockpit. . It was fortuitous that the raft did not hit anything or anybody; the result of a 53 Kg life raft hitting a crewmember at 77 Km/hr is unlikely to be a happy one.

- 6.7.7 Further, the regulations should require the raft lanyard/painter be secured to a strong anchor point, with sufficient strength to hold an inflated raft with crew embarked in severe wind and sea conditions. This fitting should also be through bolted.

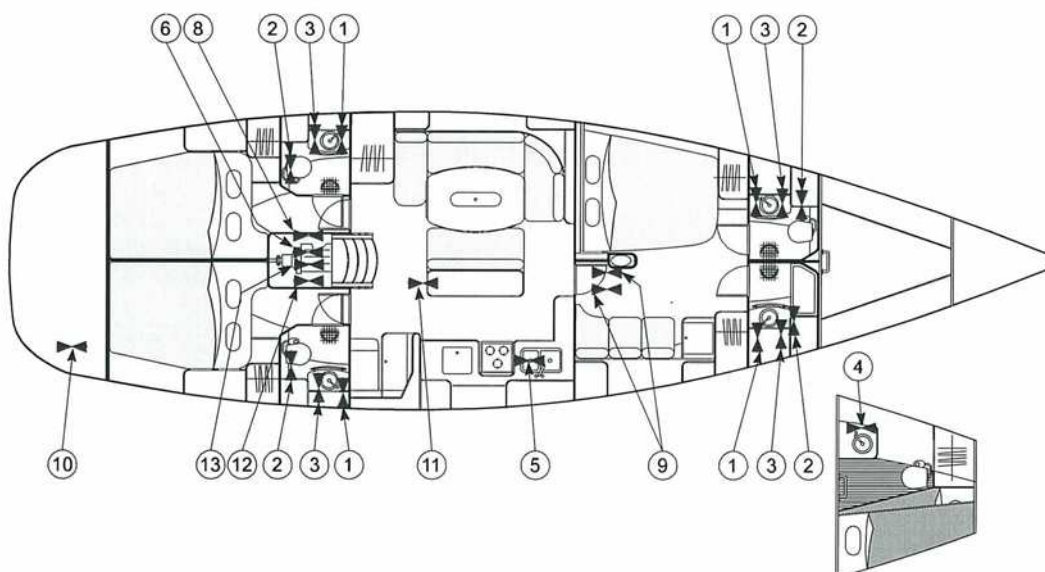
Figure 1 – Sea Cock Layout diagram from Beneteau Owner's Handbook

2. The sea cock diagram in the Beneteau Owner's Handbook has omitted the sea cocks associated with a head and a sink in the 'Skipper's Cabin' forward:

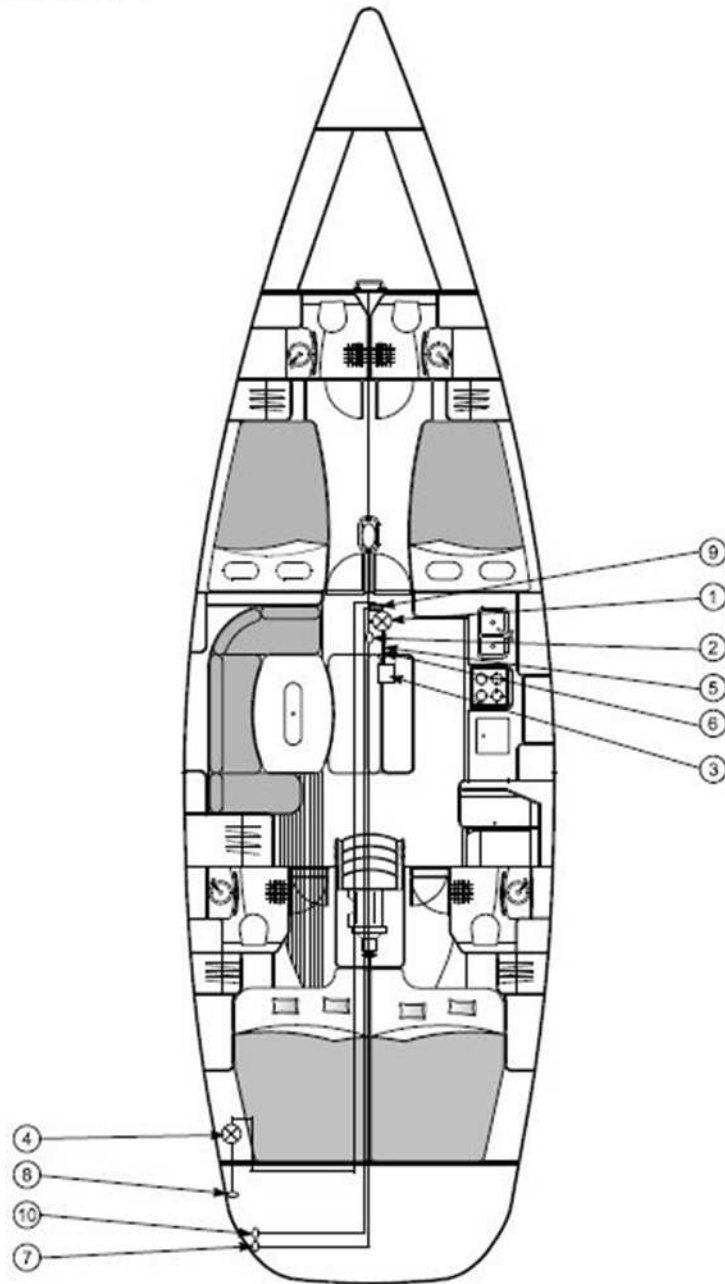
Figure 2 – Bilge Layout from Beneteau Owner's Handbook

3. The Forward cabin varied from the Beneteau Owner's Handbook as follows:

- There was only 1 head in the forward cabin; this is on the port side.
 - There is a sink and shower drain on the Starboard side.
4. The state of the associated sea cocks was not known, if the head had been used then they could well have been open, the boat did not have a strict routine about shutting unused sea cocks. The state of the sea cocks was not checked pre sailing.

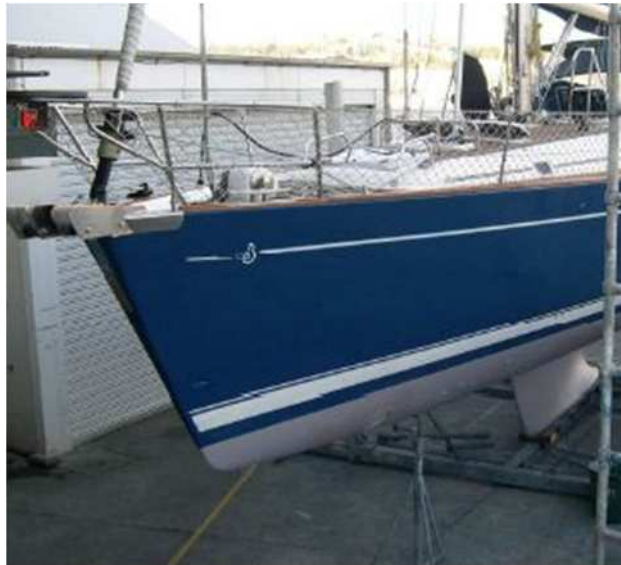
Figure 3 – Photograph of Inception Showing Sea Cocks on Port Forward side

Possible Failure of A Sea Cock
