Report on the investigation of
the loss of the yacht
Cheeki Rafiki
and its four crew
in the Atlantic Ocean,
approximately 720 miles east-south-east of
Nova Scotia, Canada
on 16 May 2014

At about 0400 on 16 May 2014 the UK registered yacht *Cheeki Rafiki* capsized approximately 720 miles east-south-east of Nova Scotia, Canada while on passage from Antigua to Southampton, UK. Despite an extensive search that found the upturned hull of the yacht, the four crew remain missing.

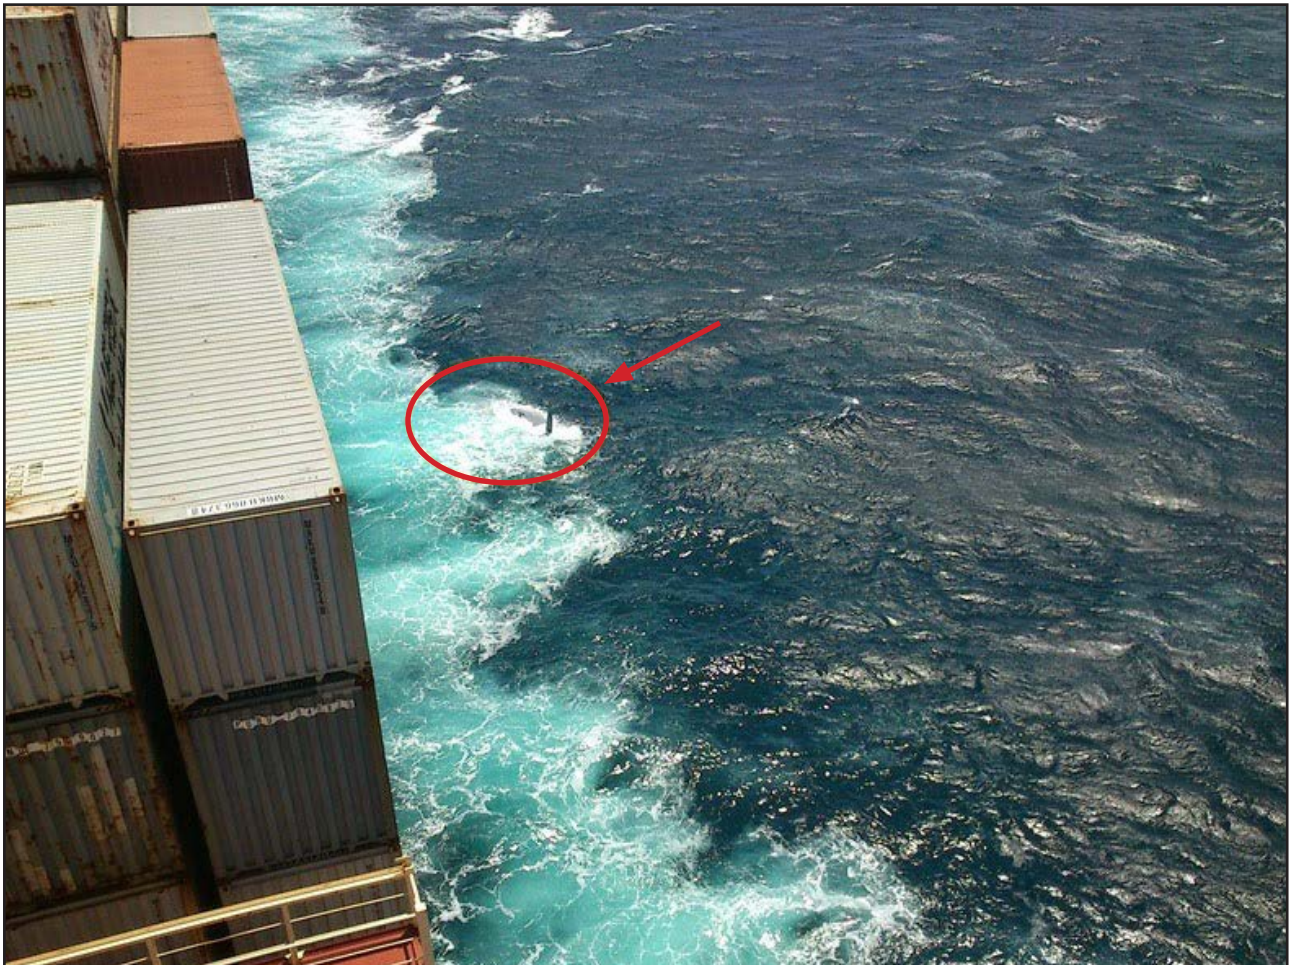
At about 1400 on 17 May 2014, the container ship *Maersk Kure* located the upturned hull of a small boat, which was believed to be *Cheeki Rafiki*. Adverse weather conditions prevented launching the ship's lifeboat or rescue boat (**Figure 6**) to carry out a closer inspection.

Figure 6: Photograph showing the upturned hull of a small boat alongside the container vessel *Maersk Kure* taken on 17 May 2014 at about 1400

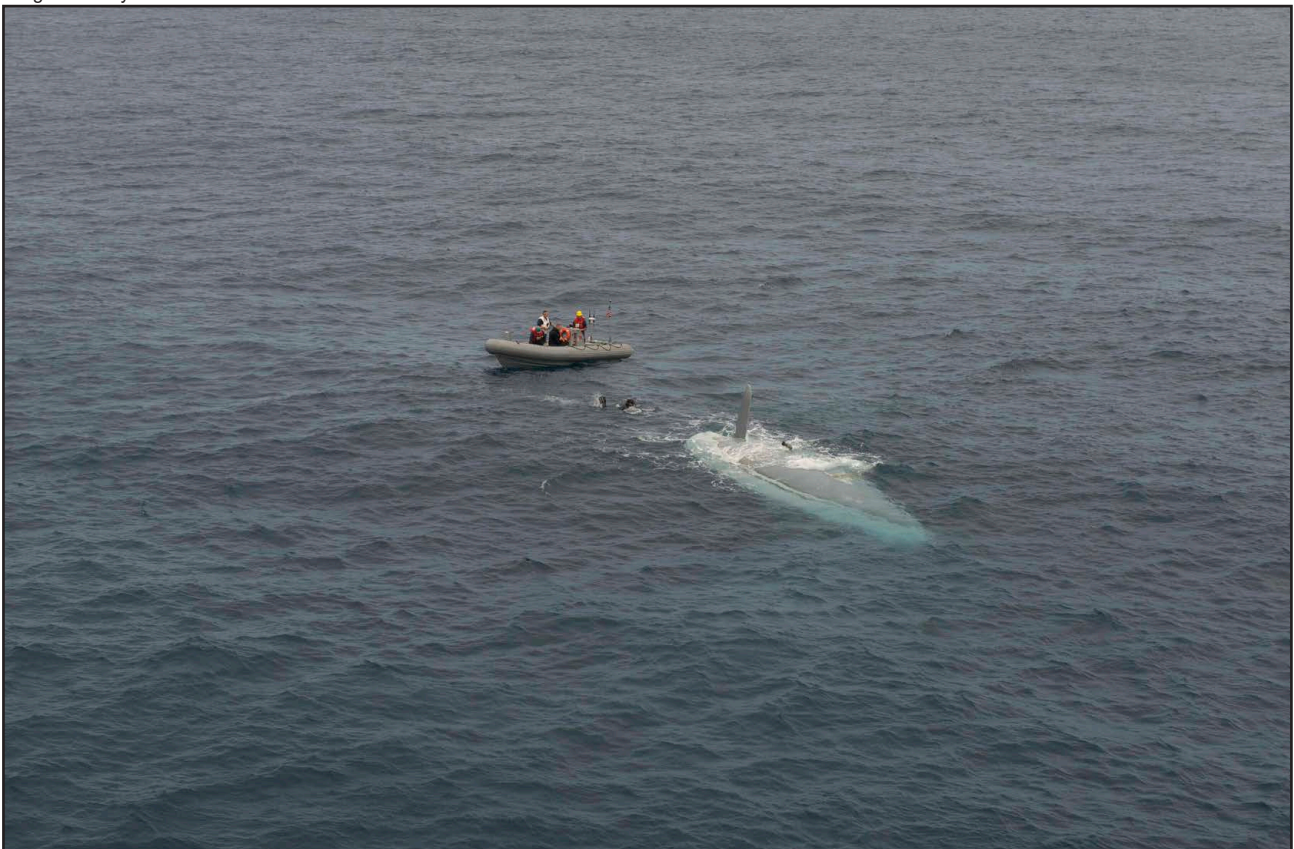
Figure 7: Photograph of Cheeki Rafiki's upturned hull being inspected by the US Navy

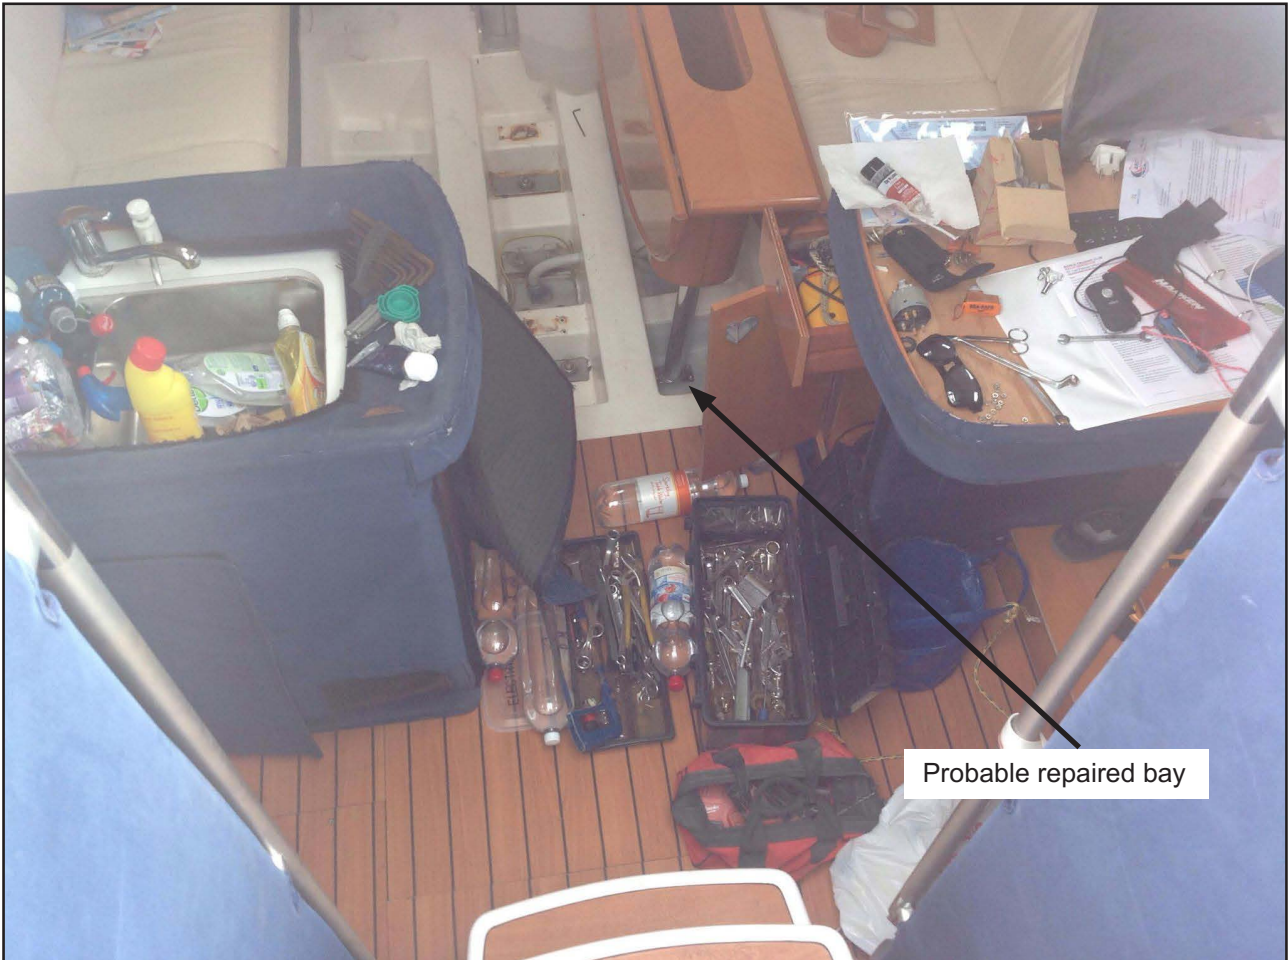
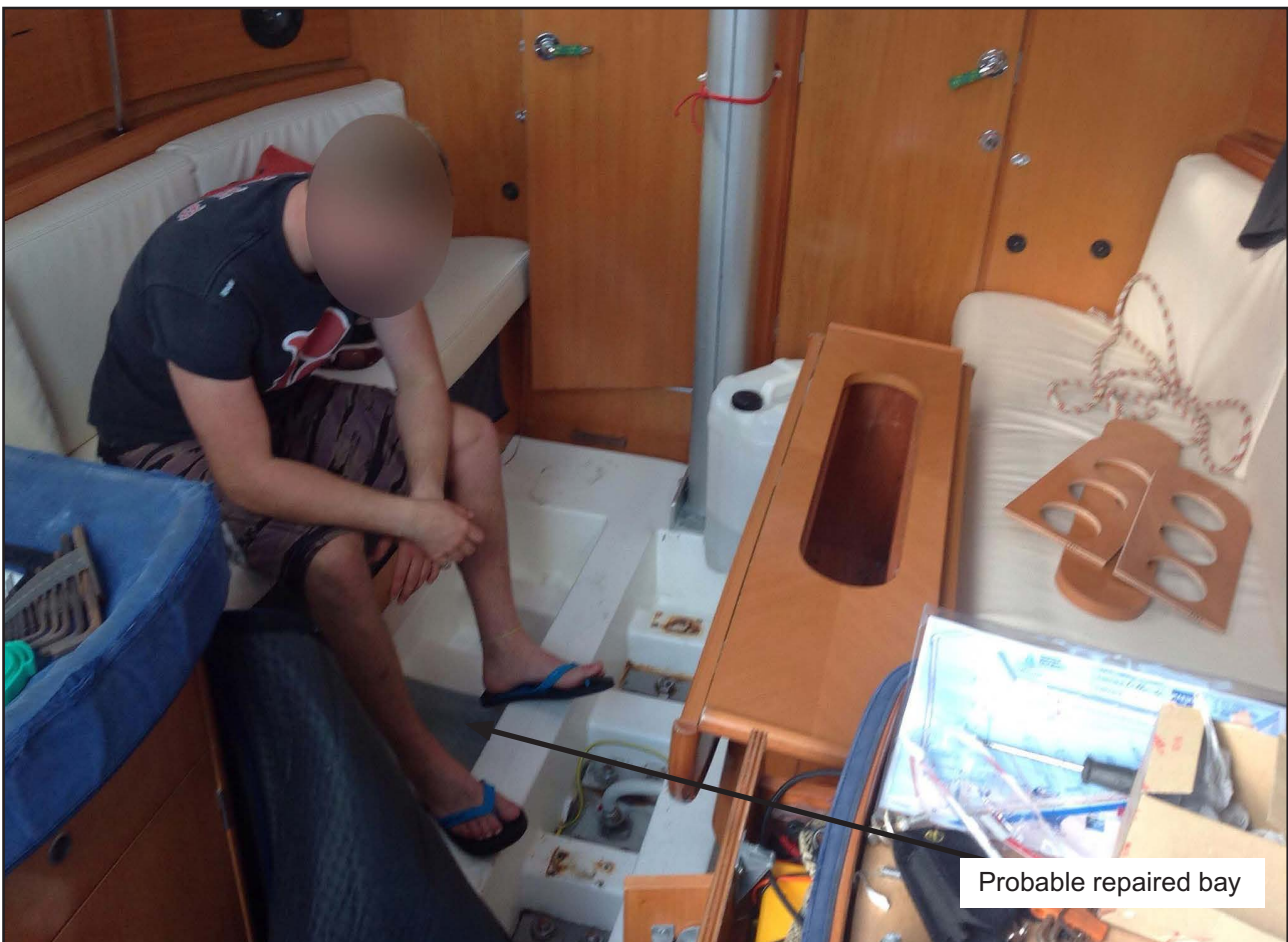
The repair invoice also indicates that the repair was not carried out in accordance with Beneteau's recommended method contained in the advice to its after sales and dealer network. Of the repairers visited by MAIB inspectors, there was divided opinion as to the appropriate repair method and, again, there is currently no industry-wide guidance on this matter.

Figure 16: *Cheeki Rafiki's* keel bilge area prior to departure on the ARC 2013, with table temporarily removed

Figure 17: *Cheeki Rafiki's* keel bilge area prior to departure on the ARC 2013, with table temporarily removed

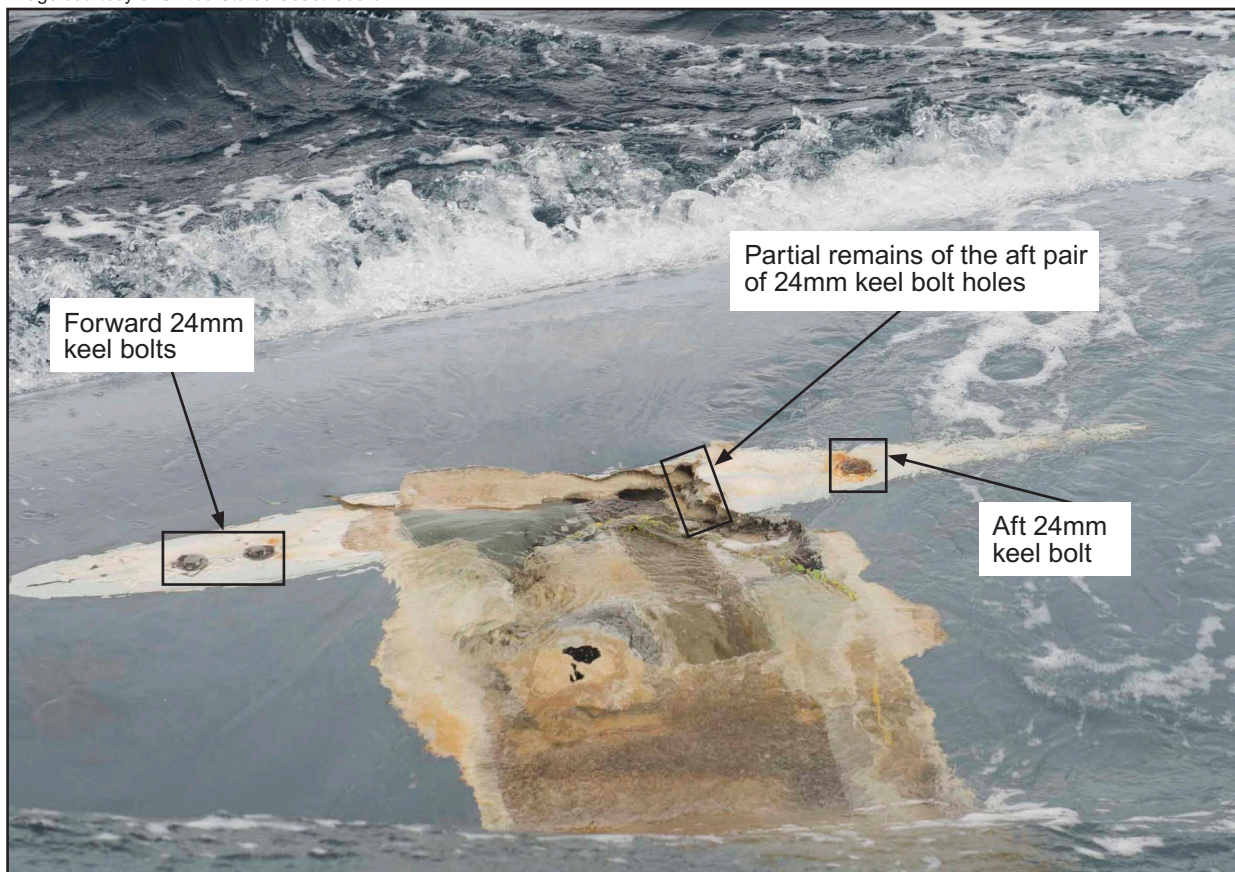
In the absence of survivors and material evidence, the causes of the accident remain a matter of some speculation. However, it is concluded that *Cheeki Rafiki* capsized and inverted following a detachment of its keel. In the absence of any apparent damage to the hull or rudder other than that directly associated with keel detachment, it is unlikely that the vessel had struck a submerged object. Instead, a combined effect of previous groundings and subsequent repairs to its keel and matrix had possibly weakened the vessel's structure where the keel was attached to the hull. It is also possible that one or more keel bolts had deteriorated. A consequential loss of strength may have allowed movement of the keel, which would have been exacerbated by increased transverse loading through sailing in worsening sea conditions.

Figure 18: Photograph of *Cheeki Rafiki*'s upturned hull taken by the crew of USS *Oscar Austin* in the afternoon of 23 May 2014

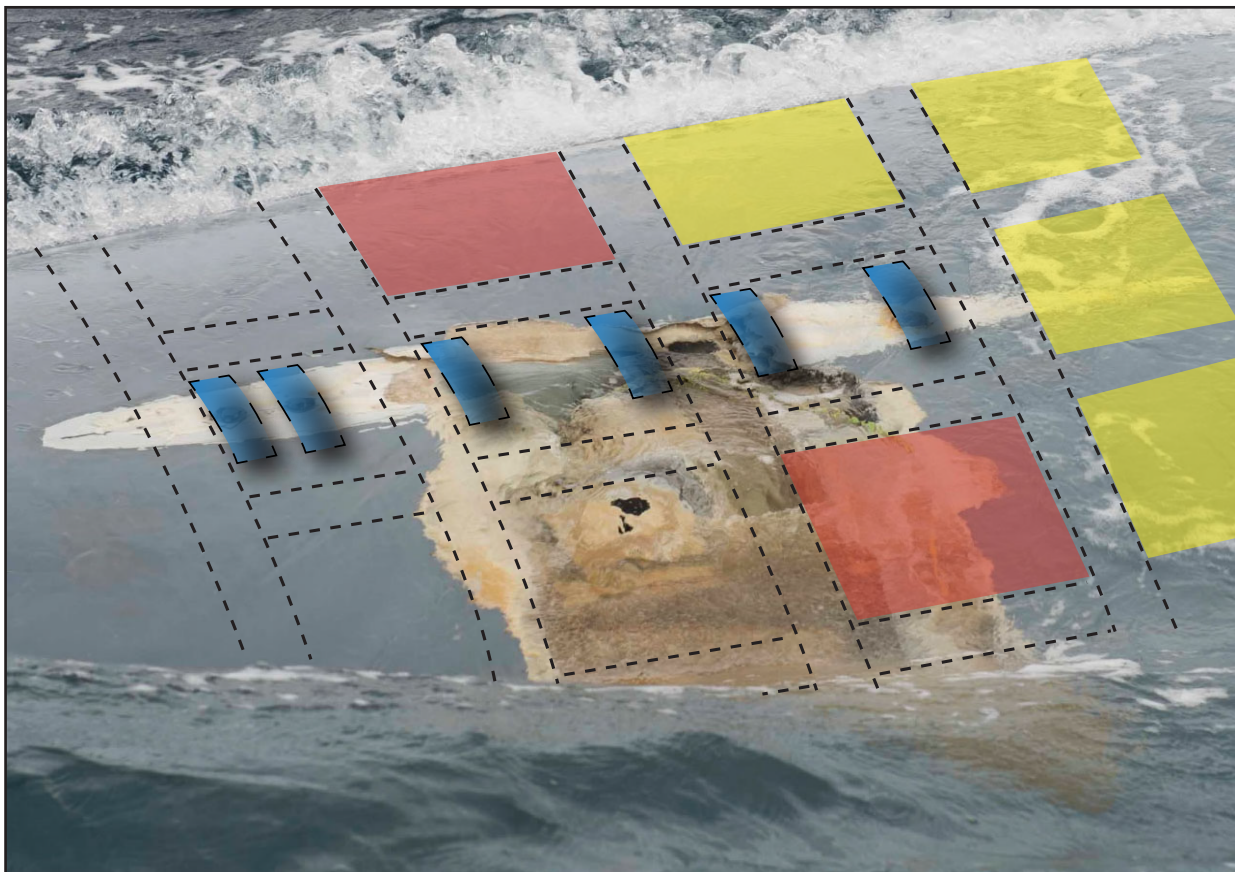
During Cowes Week in August 2007 *Cheeki Rafiki* suffered what was described as a 'light grounding' in Stanswood Bay, in The Solent. It was subsequently inspected by a GRP repairer who had the vessel lifted out of the water and temporarily rested it on its keel to enable inspection for signs of hull deflection. The matrix was then hammer tested in an attempt to identify detached areas. Repairs to the vessel were completed in September 2007.

'Remove floor boards and pipe work in way of damaged areas. Cut flanges off six bays, grind back hull, laminate and sides of structural floors. Bond structural floor to hull with GRP, lightly rub down and apply wax gel. Drill off limber holes, refit pipes and floors. Clean vessel. Lift plate washers and re bed'.

Cheeki Rafiki's keel was not removed to carry out these repairs.

Figure 19: Figure 18 superimposed with the approximate position of the matrix frames and location of the bays probably (red) and possibly (yellow) repaired in 2007
