Report on the investigation of
a fatal man overboard from the Reflex 38 yacht
Lion

14.5 miles south of Selsey Bill, West Sussex

18 June 2011

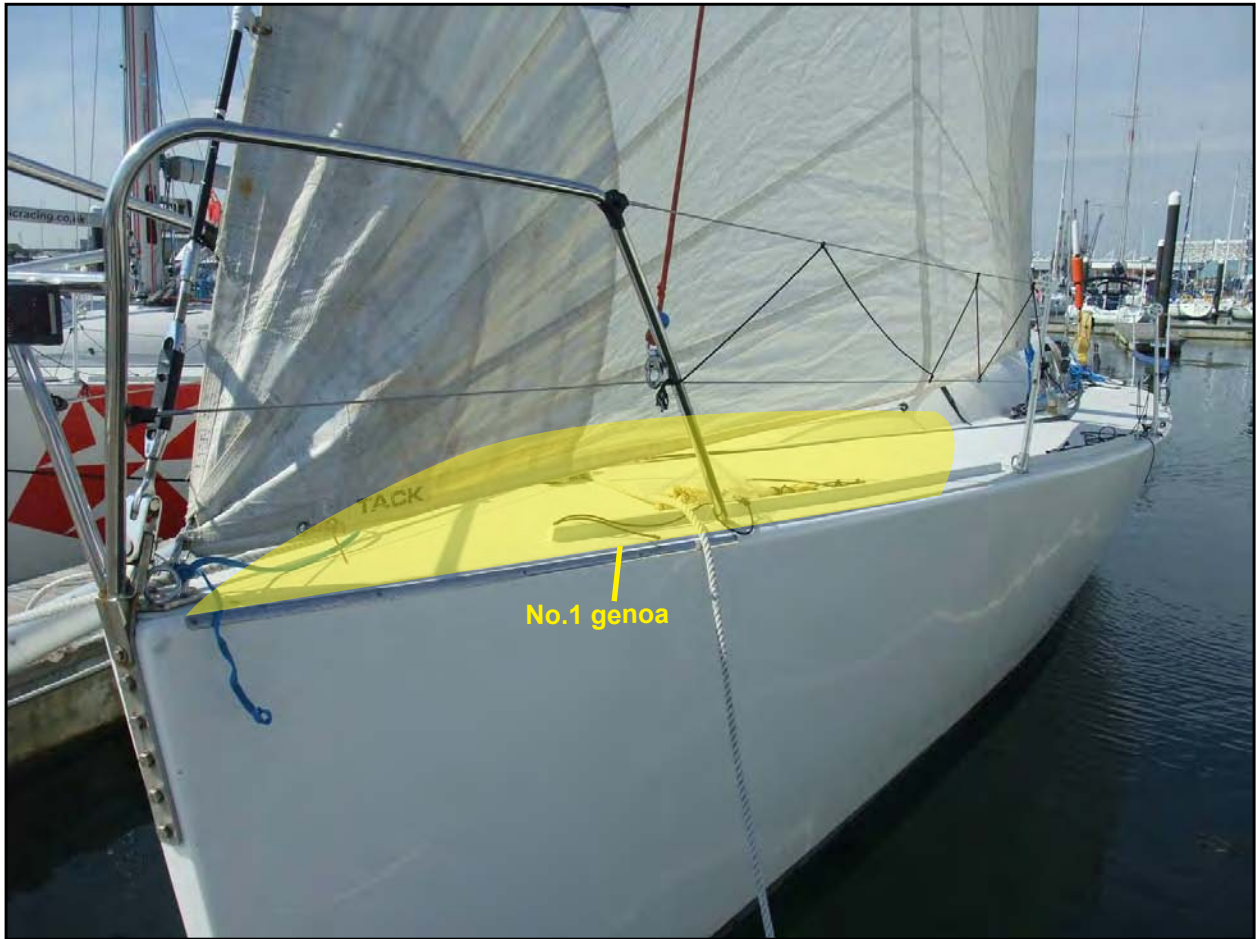
As the weather deteriorated, trimmer 2 noticed that the No.1 genoa was slipping from its lashings. He clipped his tether to the starboard jackline, went forward up the starboard side and used two additional sail ties to re-secure it.

At 0027, the helmsman felt the yacht's handling characteristics change. At the same time, he noticed that the No.1 genoa had slipped from its lashings and was streaming down the port side of the yacht. However, the tack remained secured to the forward pad eye, which prevented the sail from floating away. The skipper called the bow and mast men to the deck to help recover the sail if required. Meanwhile the helmsman concentrated on maintaining a steady course to assist the recovery operation. As the mast man entered the cockpit he noted the wind speed indicator was reading 38 knots. The yacht was heeling to port with her toerail dipping into the water.

Figure 3: Position of the lashed No.1 genoa

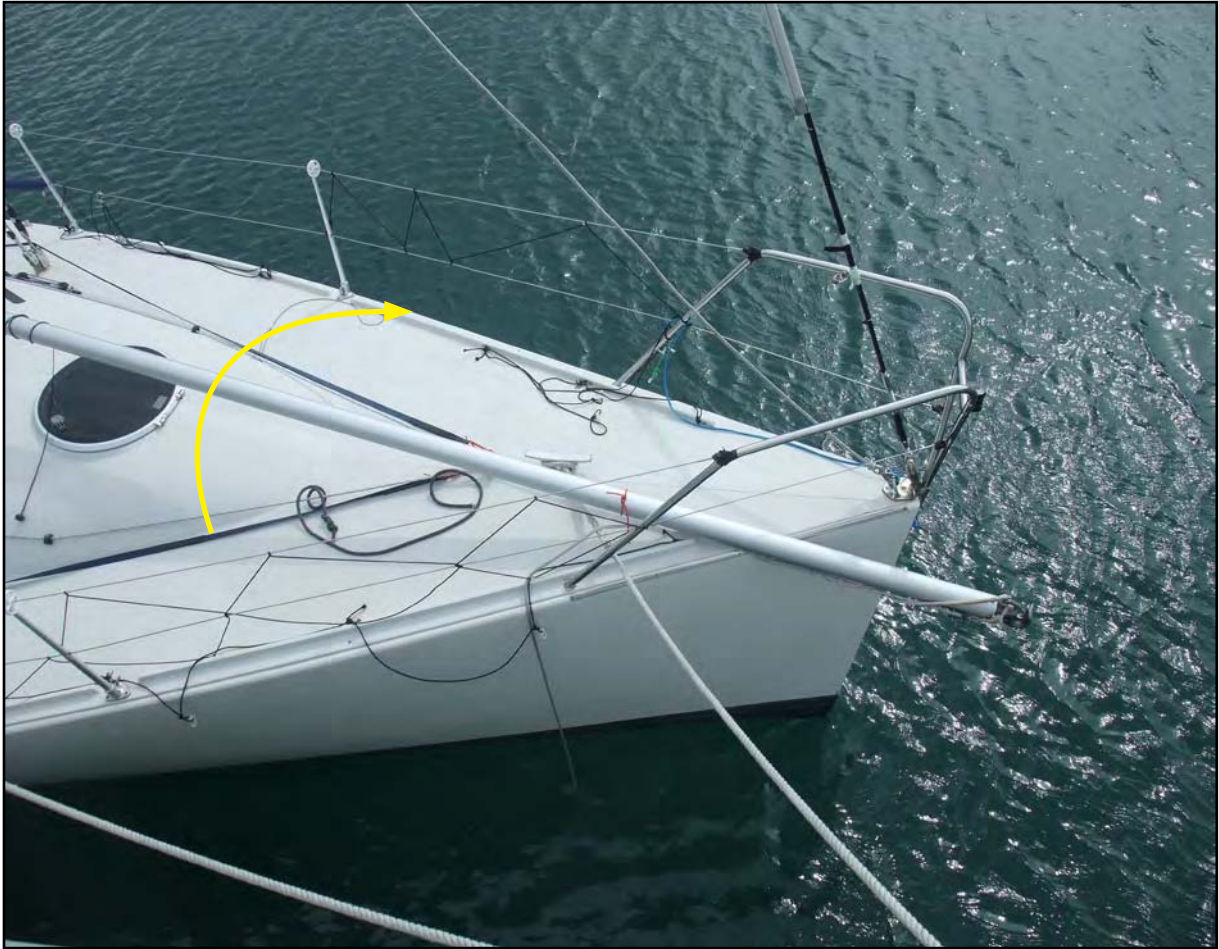
Figure 7: Approximate path believed to have been taken by the skipper when falling overboard

There is no doubt that the skipper went overboard on the port side. However, none of the crew could recall if his tether from the starboard jackline had passed over or under the spinnaker pole. A person, under momentum, could have passed through the 290mm gap under the pole, which could have also lifted as it was hinged to the mast. However, members of the recovery team do recall leaning over the spinnaker pole to pull on the skipper's tether. Had the tether passed under the pole, the weight of the skipper would have forced the tether to the deck and the crew would have suffered damage to their hands as they tried to gain grip on the tether with it pressed against the deck. In addition, had the skipper passed under the pole, it would have lifted as he was hauled inboard by the spinnaker halyard, which was connected to his tether. There is no evidence of this.

In the absence of any medical condition that might have caused the skipper to fall overboard, it is concluded that he probably either lost his footing or was swept away by a combination of the yacht's heel to port, the yacht's motion, and seas being shipped over the foredeck.

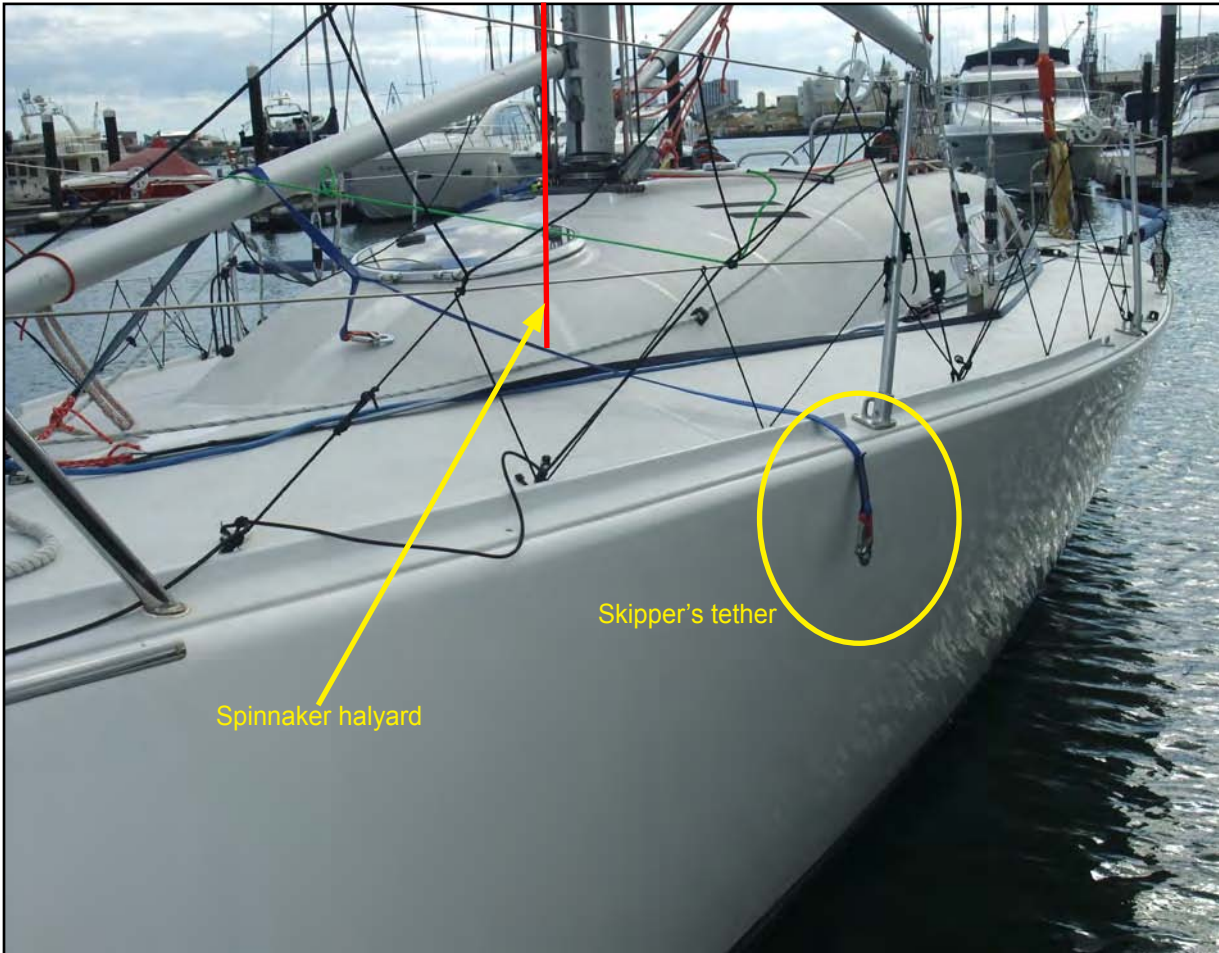
The skipper was found in the water on the port side with his lifejacket inflated and the lifejacket bladder over his head, obscuring part of his face. His tether was still connected to the starboard jackline and had passed over the spinnaker pole and under the lower guard wire between the pulpit and the first vertical stanchion (**Figure 7**). The mast and bow men went to the port side and attempted to pull the skipper out of the water. Trimmers 1 and 2 remained on the starboard side; they leant across the spinnaker pole and hauled on the skipper's tether. The team managed to raise the skipper's head above water, but there was no reaction from him. Attempts by the mast man to clear the skipper's airways and check for signs of life proved very difficult because of the obstructing lifejacket bladder.

Figure 8: Pictorial interpretation of the spinnaker halyard connected to the skipper's tether

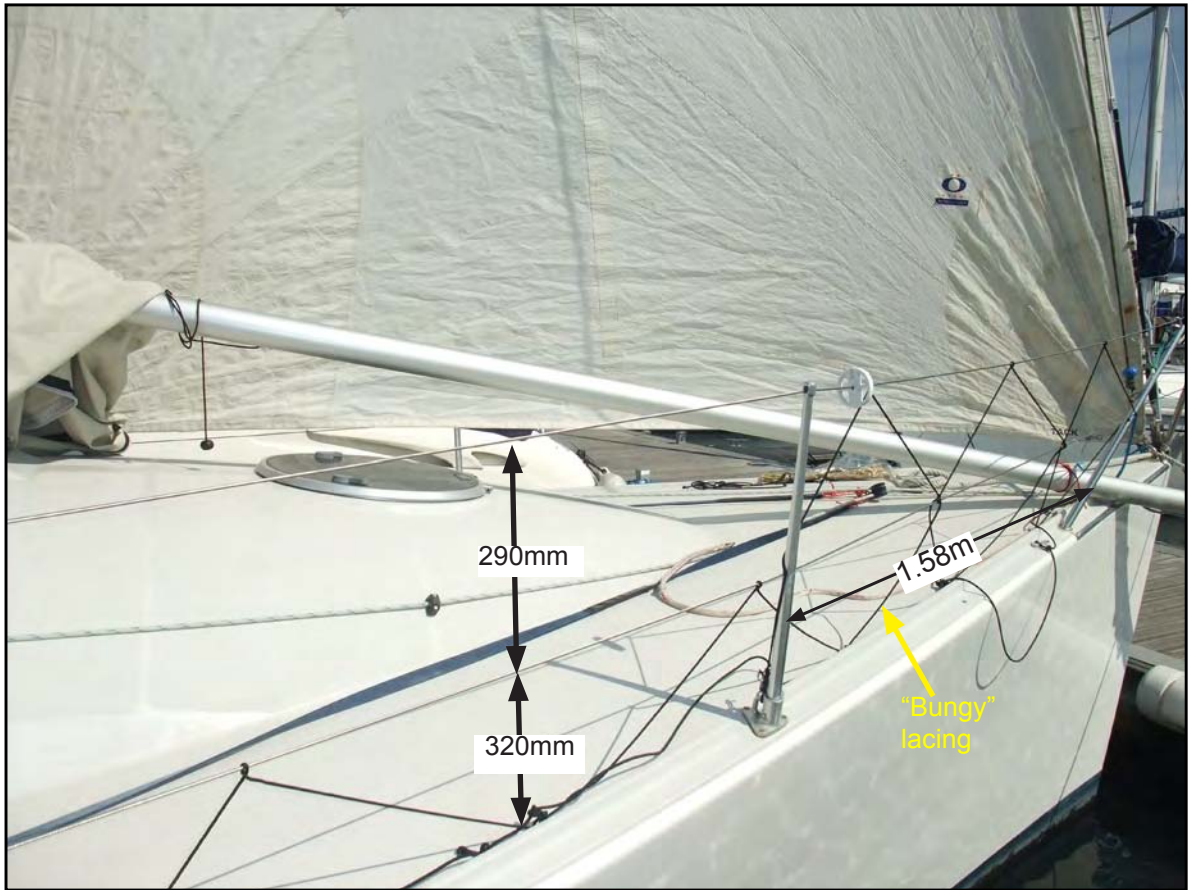
Lion's stainless steel vertical guard wire stanchions were 635mm high and equi-spaced at 2.14m intervals. The spacing between the lower end of the angled pulpit stanchion to the first vertical guard wire stanchion was 1.58m. Two stainless steel guard wires were fitted. The spacing from the deck to the lower guard wire was 320mm⁴, and from the lower to the upper guard wire, was 290mm.

A criss-cross combination of light “bungy” line and braided cordage lacing was used to help prevent sails from falling overboard. The lacing was fitted on each side from the deck to the upper guard wire between the pulpit after stanchion and the first vertical guard wire stanchion, and from the deck to the lower guard wire between the first and second vertical guard wire stanchions.

Figure 10: Stanchion, guard wire and lacing arrangements

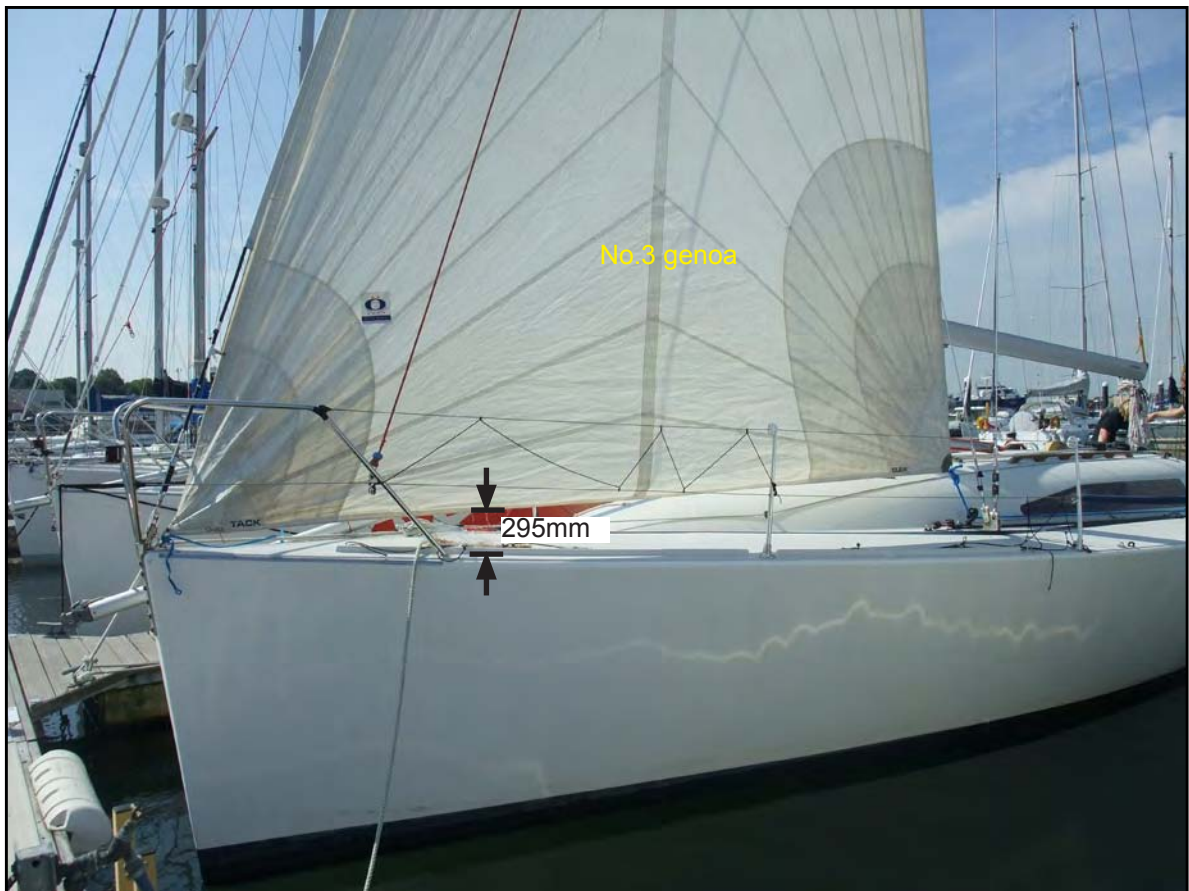
Figure 11: Gap between the foot of No.3 genoa and the deck

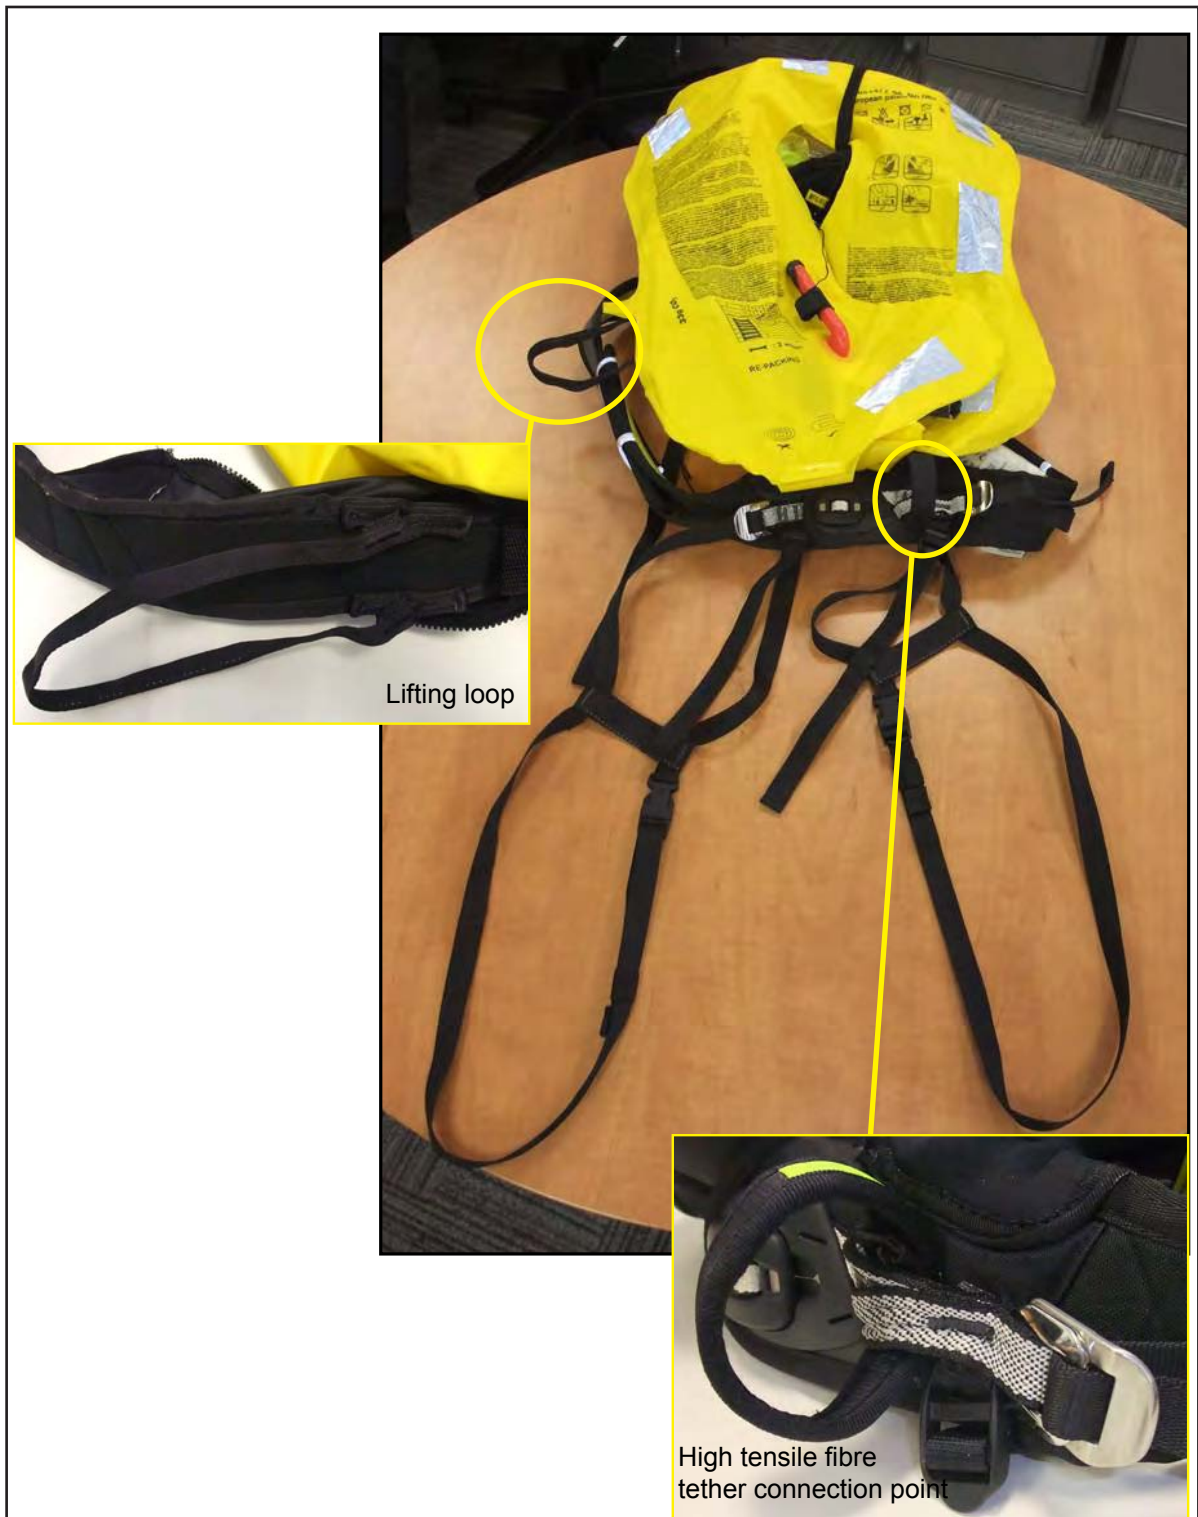
On inspection following the accident, the lifejacket, harness and thigh straps were found to be in good condition with no obvious damage to their components. The arrangement is shown at **Figures 12** and **13**.

Figure 12: Skipper's Spinlock Deckvest 150 Pro Sensor lifejacket, harness and thigh straps

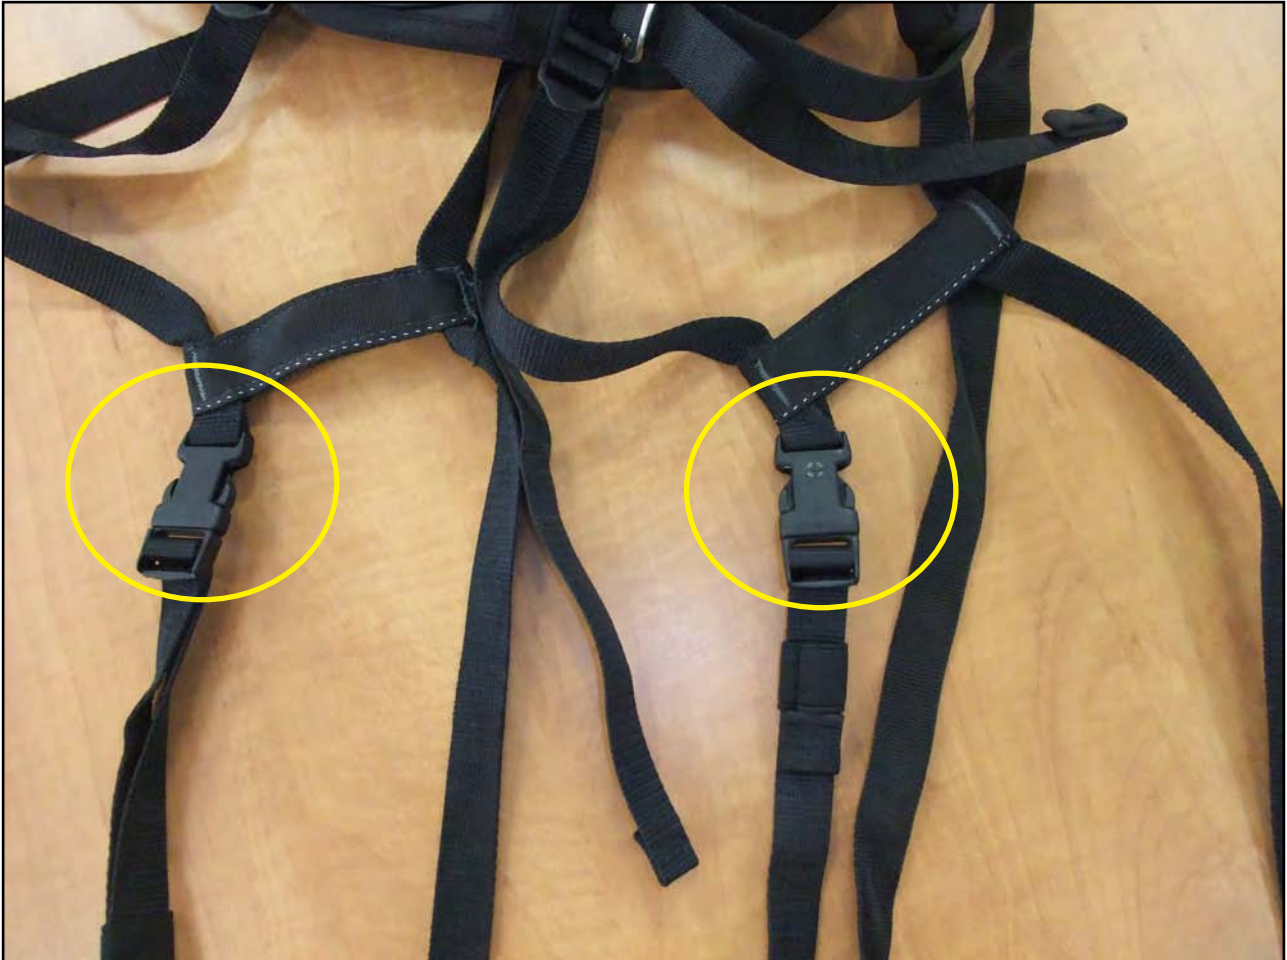
Following the accident it was noted that the thigh strap side release buckles were easily unclipped under straight load tension, and especially so under rotational load. Straight pull load tests showed that the left and right thigh strap buckles released when a load of 20 kilogram-force (kgf) and 40kgf was applied respectively. It is understood from the lifejacket manufacturer that the buckles should withstand a 50kgf load before unfastening.

Figure 13: Spinlock Deckvest 150 Pro Sensor lifejacket thigh strap side release buckles

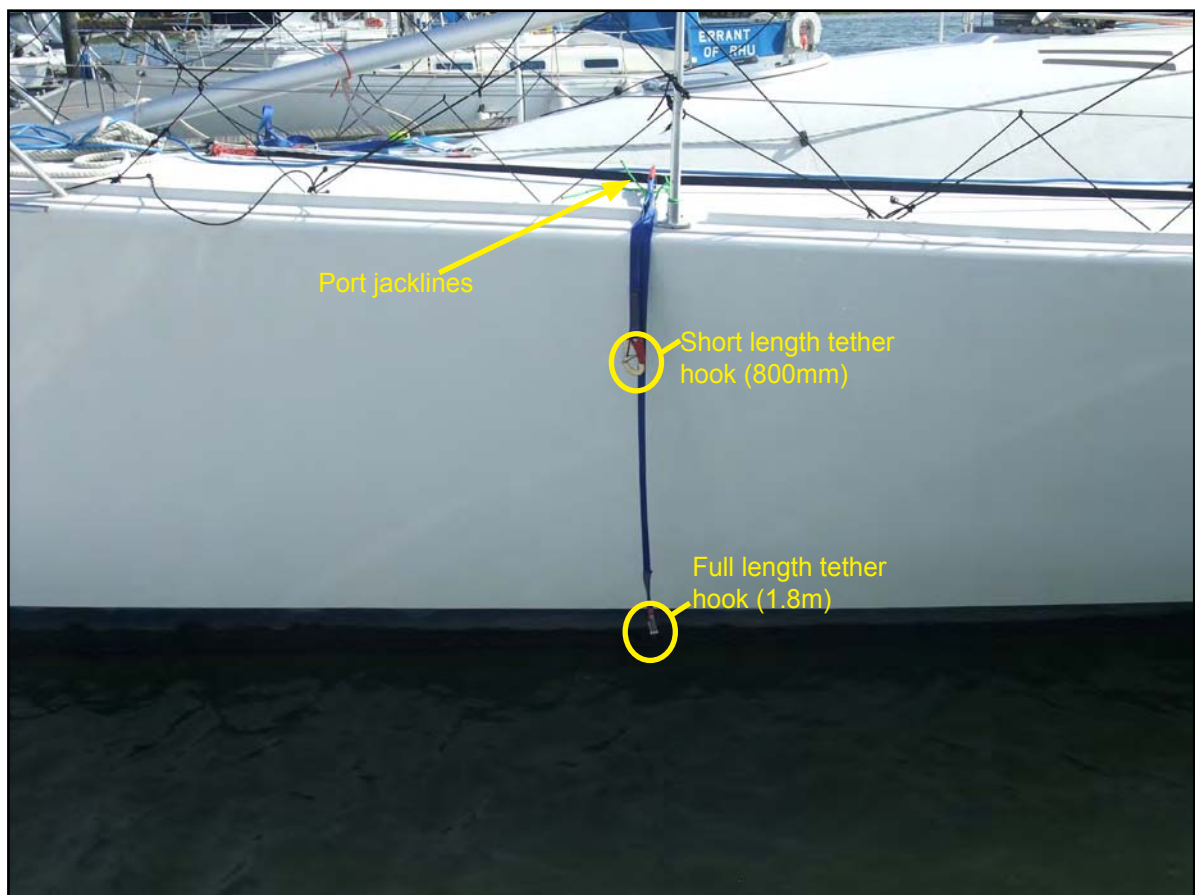
When a three-hook tether was connected to the deflected port jackline, the long and short tethers extended 1.2m and 500mm over the port deck edge respectively (**Figure 16**).

Figure 16: Three-hook tether connected to the port jackline

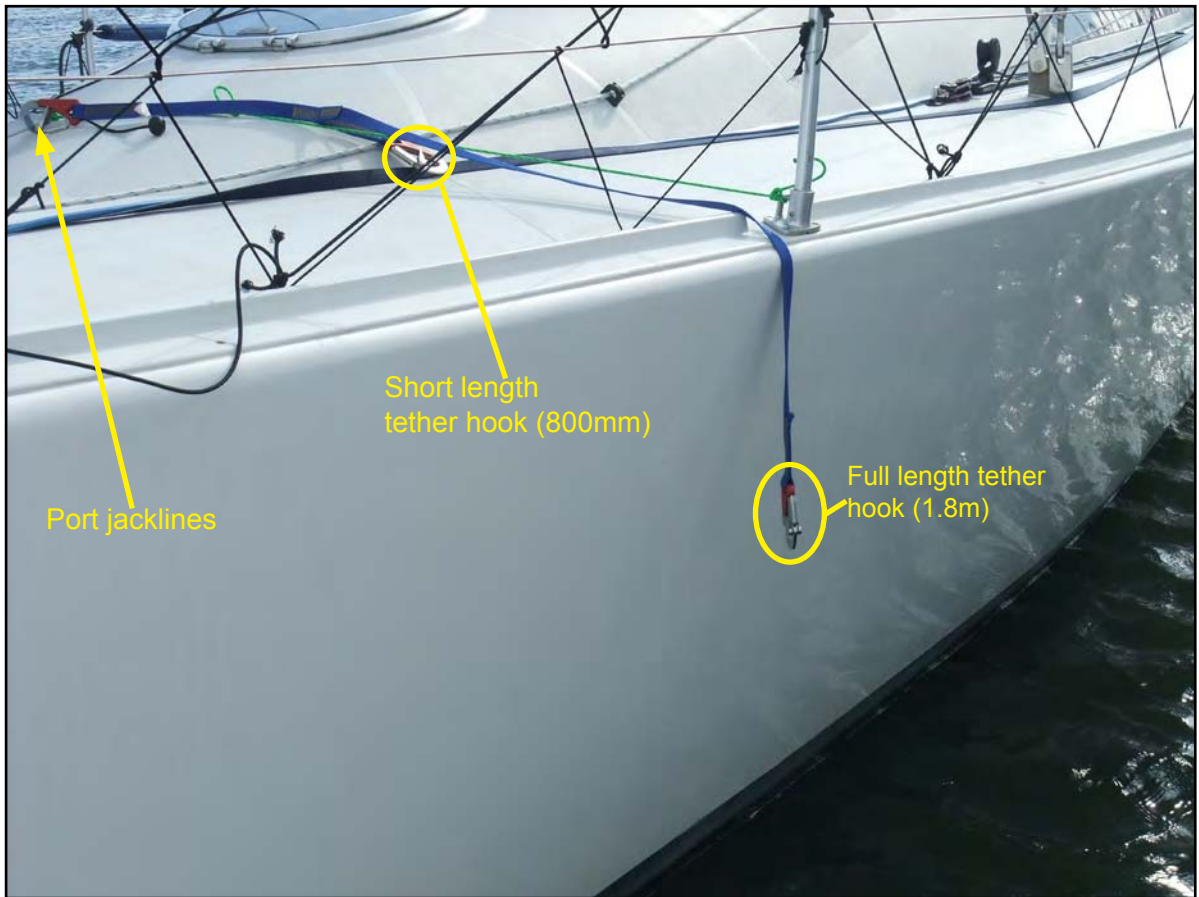
When the same three-hook tether was connected to the starboard jackline and passed under the spinnaker pole, the long tether extended 450mm over the port deck edge. When passed over the spinnaker pole it extended 250mm over the port deck edge (**Figure 17 and 18**). In both cases the short tether hook remained well clear of the port deck edge.

Figure 17: Three-hook tether connected to the starboard jackline and passing under the spinnaker pole

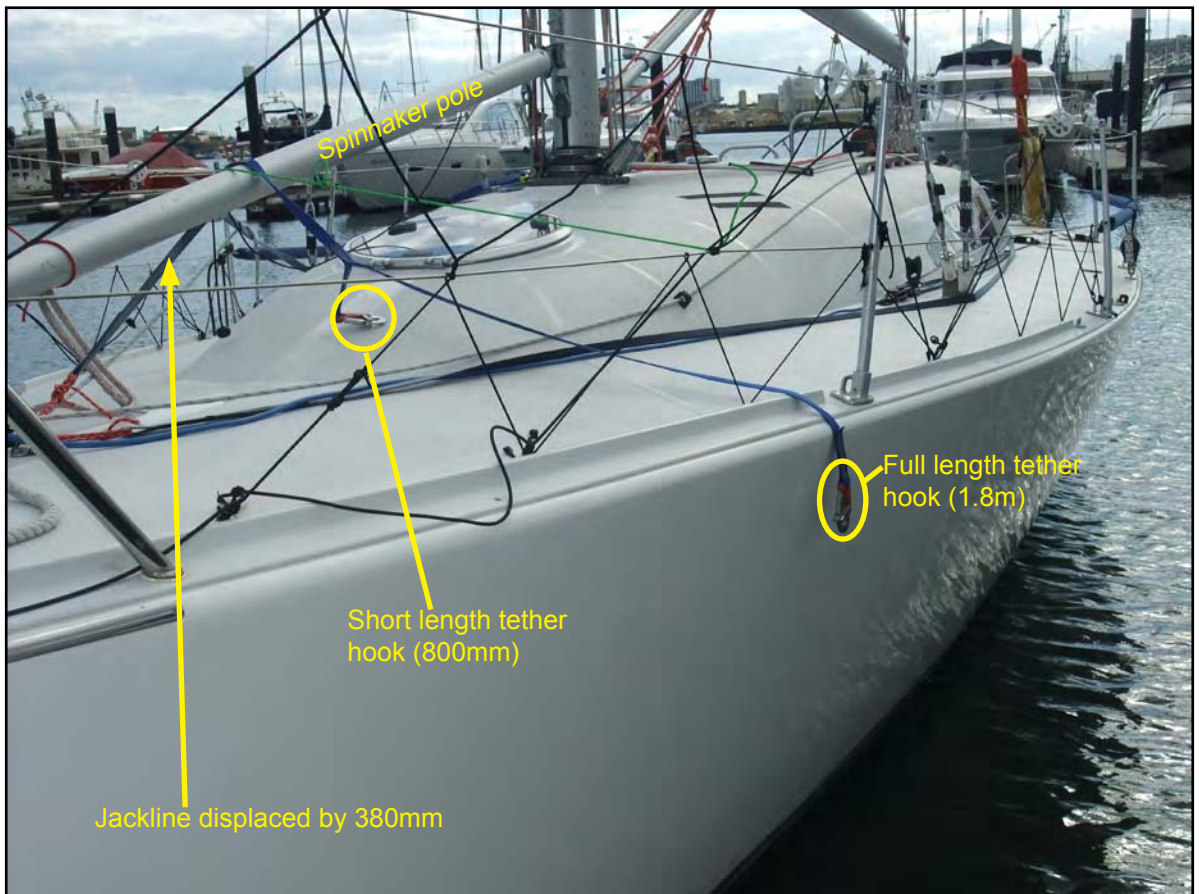
Figure 18: Three-hook tether connected to the starboard jackline and passing over the spinnaker pole
