MARINE ACCIDENT INVESTIGATION BRANCH

FLYER TO THE YACHT DESIGN, BUILDING AND REPAIR INDUSTRY

MAX FUN 35 YACHT *Hooligan V*: KEEL DETACHMENT, CAPSIZE AND LOSS OF ONE CREW

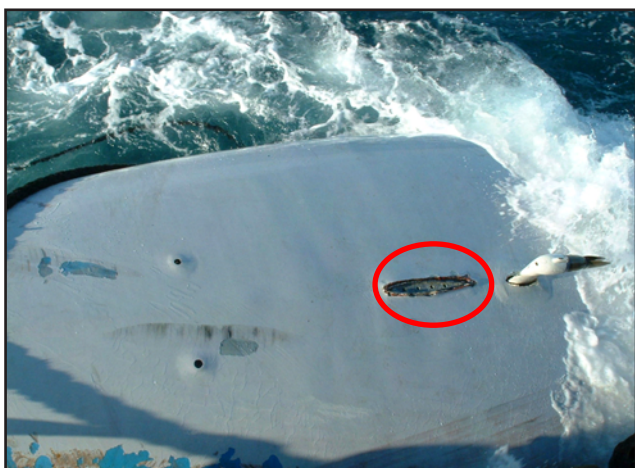
Investigations found that the fabricated steel keel had failed just below the fillet weld connecting the fin to the taper box (**Figure 1**). Laboratory metallurgical analysis confirmed that the keel had suffered fatigue failure in the fillet weld area, which had been subjected to high bending stresses. Defects were also found in the keel taper box welds, and two of the three keel bolts had also failed.

Analysis of the “original” design calculations confirmed that they did not achieve the required Safety Factor of 2. The “as built” keel safety calculations were worse, and these were exacerbated by the addition of the extra bulb weight. The fabricated keel was unable to withstand the “in service” bending stresses and this led to the conditions of failure.
