ATSB TRANSPORT SAFETY REPORT
Marine Occurrence Investigation No. 268
MO-2009-008
Final

Independent investigation into the collision between
the Australian registered yacht

Ella's Pink Lady

Silver Yang

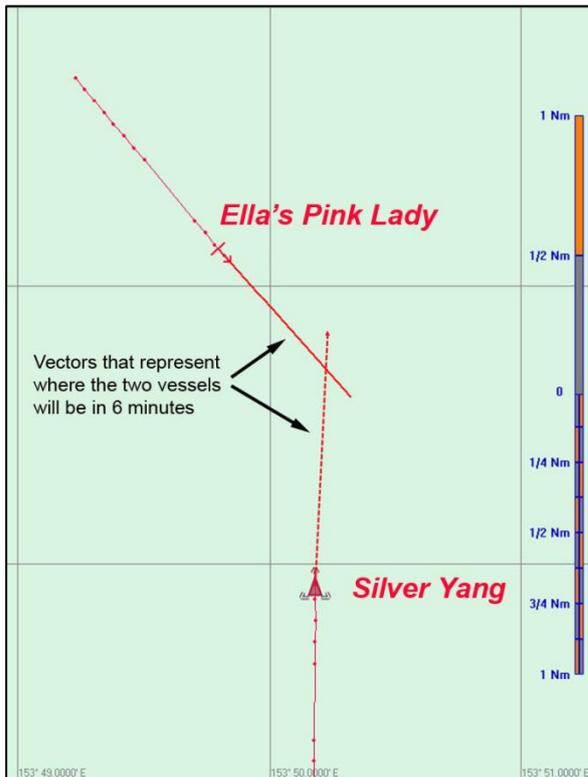
Figure 5: AIS image derived from the Point Lookout AIS base station showing the relative positions of the *Ella's Pink Lady* and *Silver Yang* at 0146

At about 0146, *Ella's Pink Lady's* skipper prepared for another catnap. The yacht was now making good a course of 144°(T) at a speed of 6.8 knots. The skipper checked the radar and noted that there was a vessel about 6 miles off the starboard quarter¹¹ (Figure 4). She could not see it visually, but she monitored its progress on the radar for about 1 minute. Once she had determined that it did not present a collision risk, she again set the radar guard-rings and alarm clocks before going to bed. By this time, *Silver Yang* was about 1 mile to the south-southeast of *Ella's Pink Lady's* position (Figure 5). However, the yacht's skipper had not detected the ship's presence.

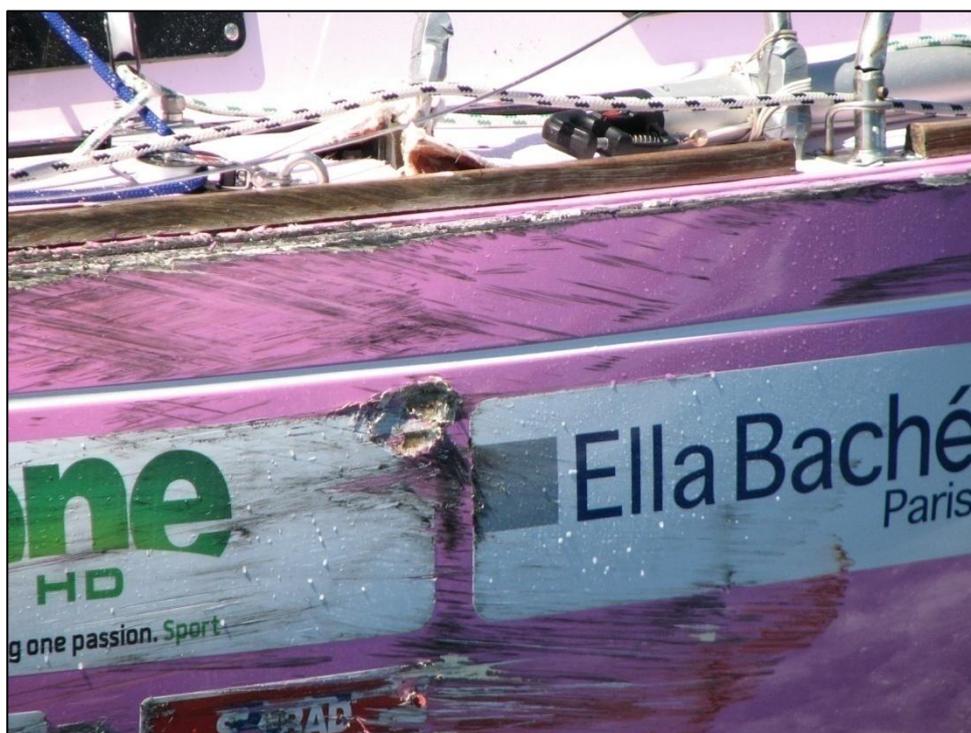
Figure 7: *Ella's Pink Lady*'s damaged starboard side

The impact of the collision pushed *Ella's Pink Lady*'s bow to port and the yacht's starboard side scraped along the port side of the ship. The collision woke the skipper and she climbed out of the cabin, grabbed the tiller and tried to steer the yacht. She looked upwards and thought that the yacht's rigging would probably become entangled with the ship and dismast her vessel, so she returned to the cabin. A few seconds later, the mast came crashing down.

Once *Ella's Pink Lady* had cleared the ship's stern, the skipper assessed the damage to her yacht (Figure 7). She found no ingress of water and, although the yacht's hull was damaged and it had been dismasted, the vessel appeared to be seaworthy. She then used the yacht's satellite telephone to call her parents. She spoke to her father and told him what had happened. While she was talking to her father, her mother telephoned the Australian Rescue Coordination Centre (RCC) in Canberra and reported the collision.

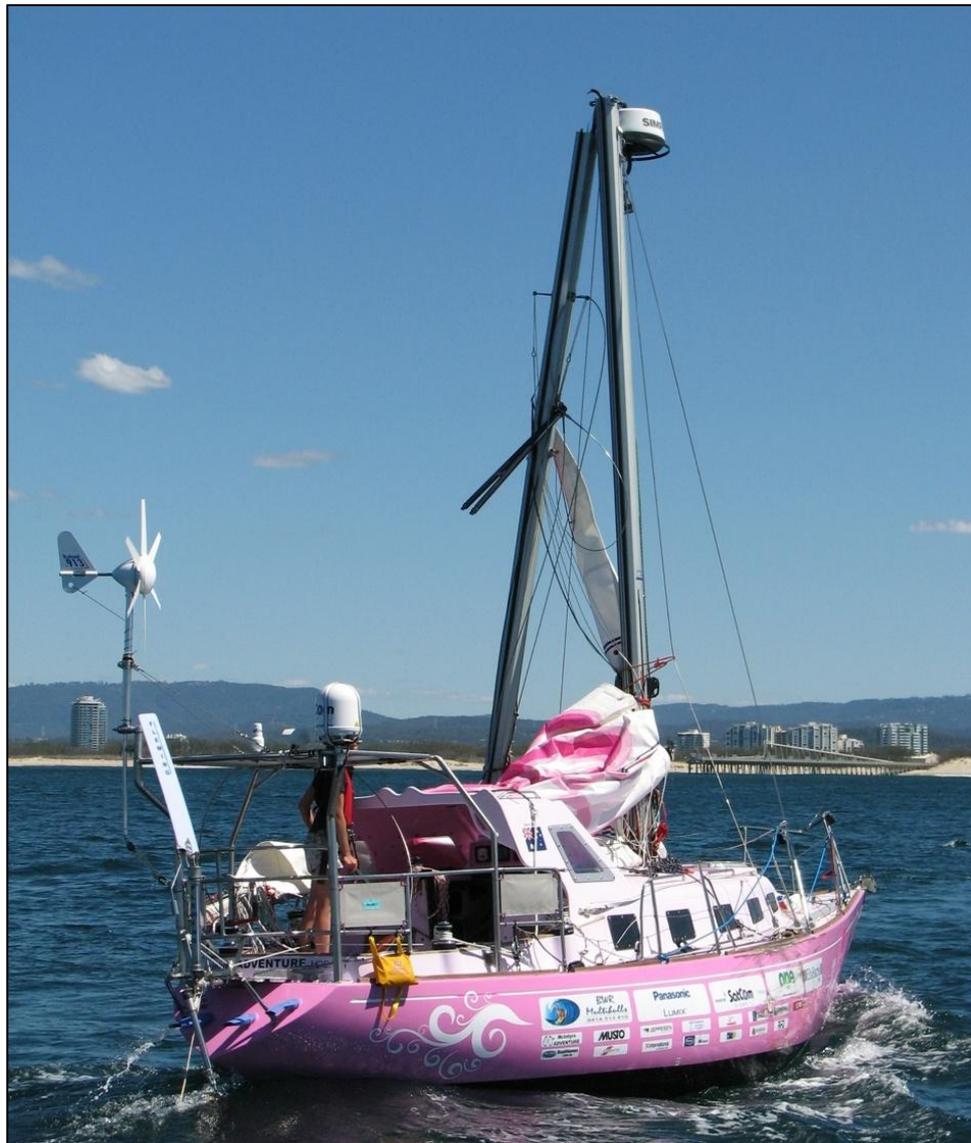
Figure 8: Dismasted *Ella's Pink Lady* motoring towards Southport

Ella's Pink Lady was dismasted as a result of the collision, but the skipper was able to cut the headsail free, retrieve the mast, the mainsail and the rigging on board and motor the damaged yacht to Southport, Queensland.
