Report 2017-02 on the investigation into the capsizing and subsequent
rescue mission of the sailing vessel

CAPELLA

Off the Belgian coast with the loss of three lives on July 1st 2017

Federal Bureau for the Investigation of Maritime Accidents (FEBIMA)

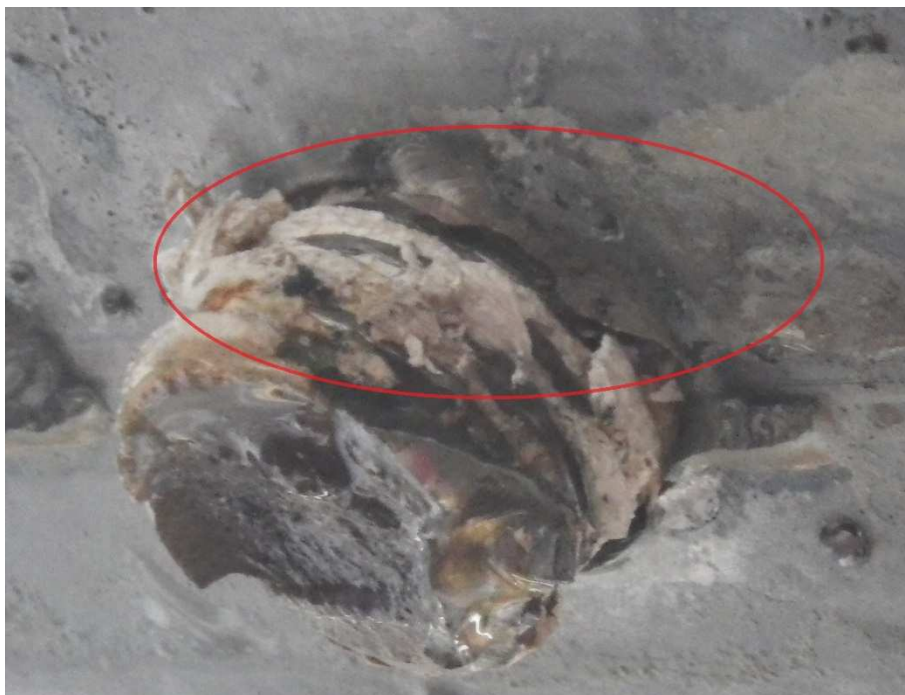
Figure 9 - Part of threaded rod welded to keel plate

The keel plate was welded perpendicularly to a stainless steel plate in the centre of the keel. The threaded rods were also welded to the bottom of the keel plate.

The welding of the keel bolts at the bottom of the keel plate, that was perpendicular to the centre plate of the keel, had resulted in the pre-tension, that had been applied to the nuts securing the bolts at the inside of the hull, being applied only to the part of the bolt from the weld to the securing nut, and the welding had eliminated all visual indicators that a bolt or bolts were broken off.

- 2) The Belgian Federal Public Service Mobility and Transport, DG Shipping, directorate pleasure craft, are recommended to inform sailing craft owners and sailing craft operators of the possible hidden dangers of failing keel bolts on sailing yachts with bolt-on keels, and to address the importance of a thorough inspection of keel and keel bolts after grounding.

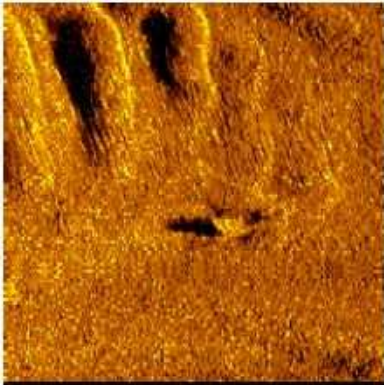
Figure 13 - SONAR location of the keel of the sy CAPELLA

Months later, at the end of the month of September 2017, a Belgian navy vessel BNS CASTOR located the sy CAPELLA's keel, by means of active sonar⁵, in position 51° 27'045 N and 003°1'105 E, or very close to the last position of the sy CAPELLA before capsizing as determined by radar, indicating that the keel of the sy CAPELLA was lost at the time of capsizing, and that the loss of the keel played a part in the capsizing.

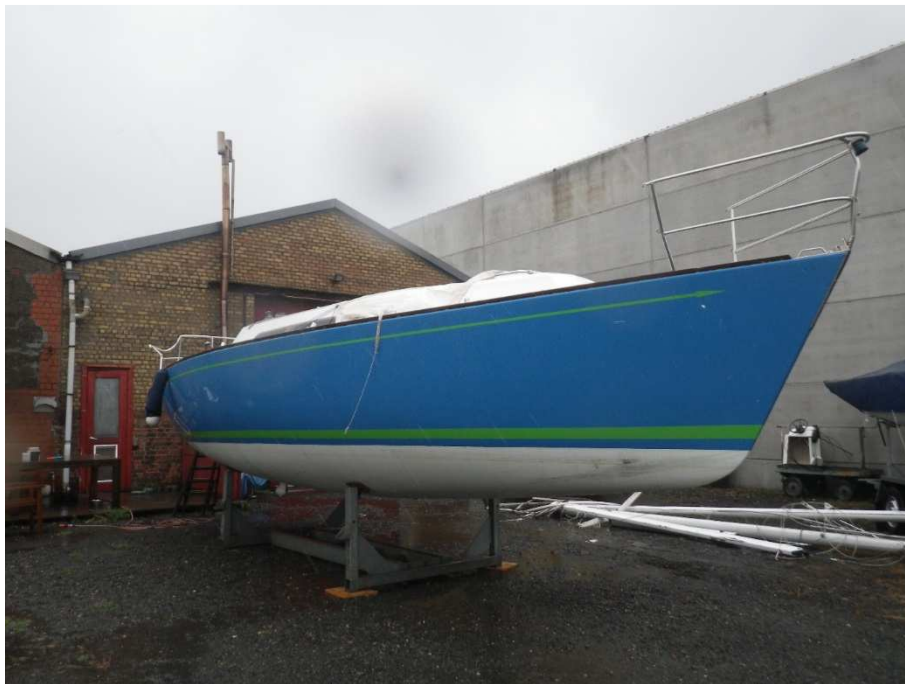
Figure 14 - sy CAPELLA as it had been stored at Zeebrugge

Apart from a damaged rig, and damaged roof of the superstructure, the latter most probably by the rigging giving way, the hull of the sy CAPELLA appeared in sound condition.

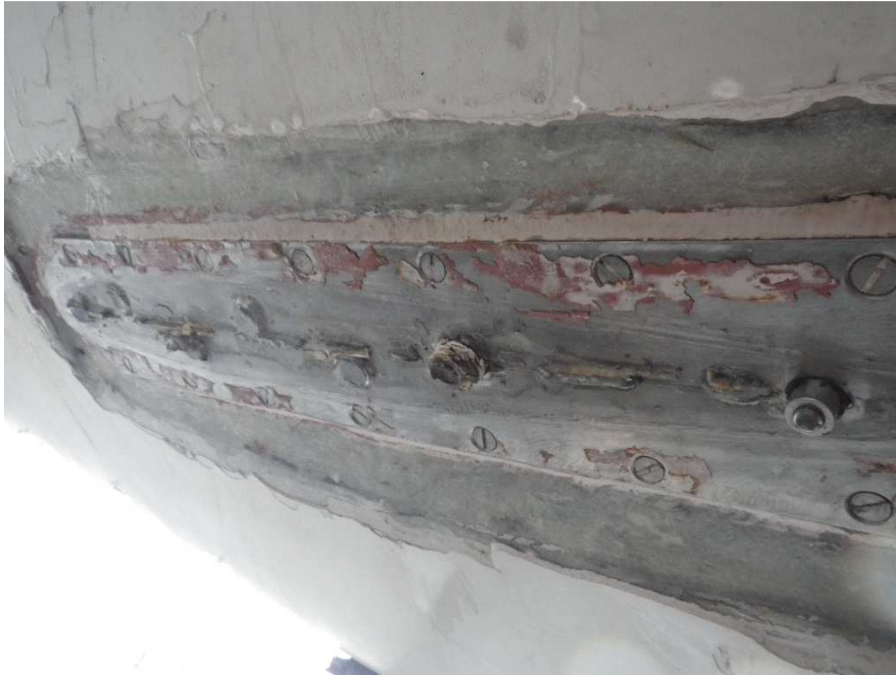
*Figure 15 - Keel plate still present on hull
with larger part of keel missing*

The keel of the sy CAPELLA was found missing. Closer investigation revealed that a part of the keel, the keel plate, was still present and in position against the vessels hull.

It was noted that the threaded rods or keel bolts, provided to keep the keel in place, were sheared off below the welds, where the threaded rods or keel bolts had been welded to the keel plate. It was also noted that all keel bolts had been positioned near the centre line of the keel.

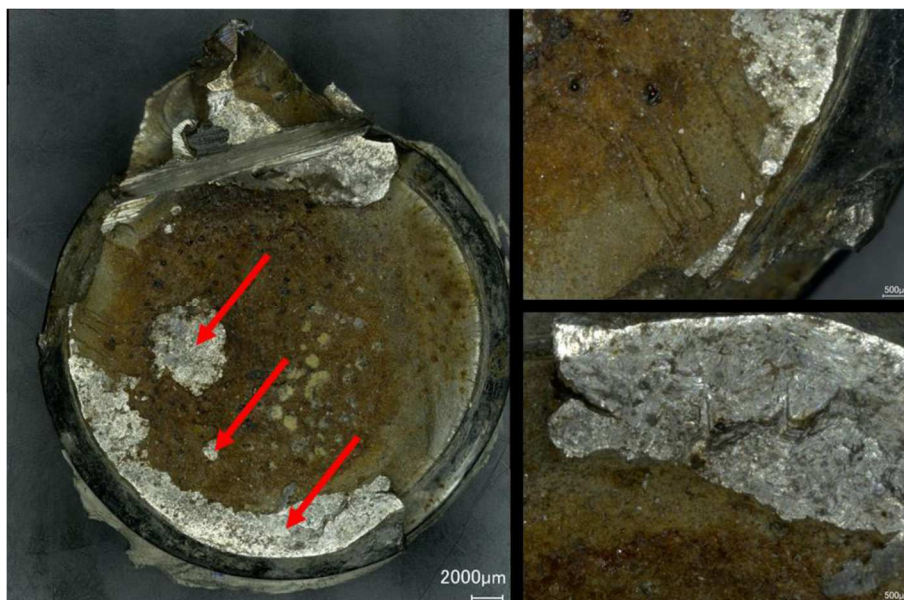
Figure 19 - Optical microscopy images of bolt 2

With the use of an optical microscope bolt 2 was investigated as seen in Figure 19. The fracture surface was highly corroded, which indicated that fracture had not occurred recently, but that the fracture surface had been submitted to seawater for a longer period of time.

The corroded nature made it hard to determine the type of failure. Some zones, indicated with red arrows in Figure 19 had a reflective appearance, which indicated that the metal was ground against another metallic part for a certain period of time. Friction between two parts of the broken off keel bolt must have taken place, so that consequentially, corrosion products were ground away or never had the chance to be formed in these particular positions

Left: fracture surface with indication of reflective surfaces. Right: more detailed image of reflective surfaces and corrosion products

Cr, Mo and Ni were part of the passive protective layer of the stainless steel, however, the presence of iron indicated that corrosion had taken place. The red rust, ferric oxide - Fe_2O_3 , was also a clear indication of the aforementioned corrosion.

Besides aforementioned elements, 10 wt% of sodium chloride - NaCl, commonly known as salt, and some small amounts of sulphur, 2 wt%, were detected. The presence of sodium chloride indicated that corrosion had taken place in saline environment, such as sea water.

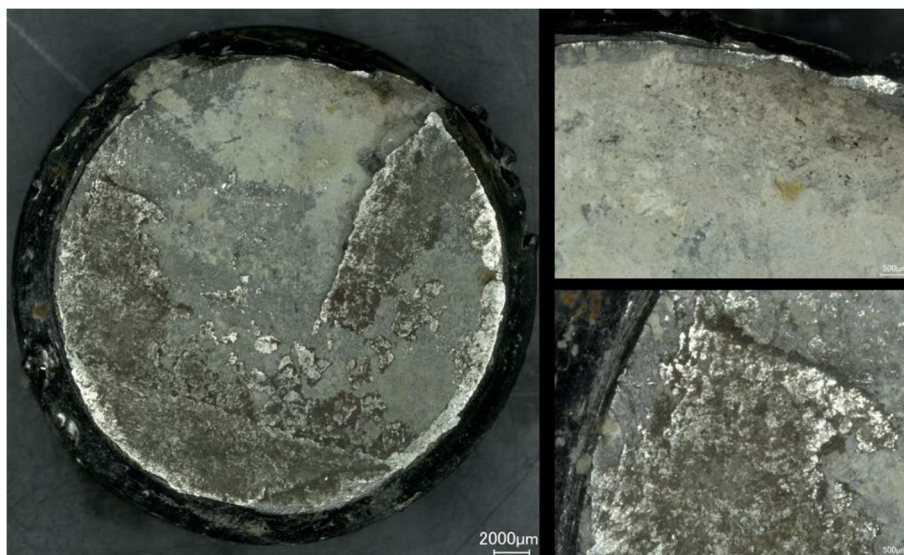
Figure 20 - Optical microscopy images of bolt 4

In Figure 20 images of optical microscopy investigation of the fracture surface of broken off keel bolt 4 are shown. In the overview left image, a white deposit was visible. Most of the fracture surface of the broken off keel bolt, when not covered with white deposits, consisted of reflective surface. Similar to the fracture surface of broken off keel bolt 2, this reflectiveness indicated that the metal surface had been ground against another metallic part.

Left: fracture surface. Right: detailed image of the white deposits (top) and reflective surface (below) of the fracture surface

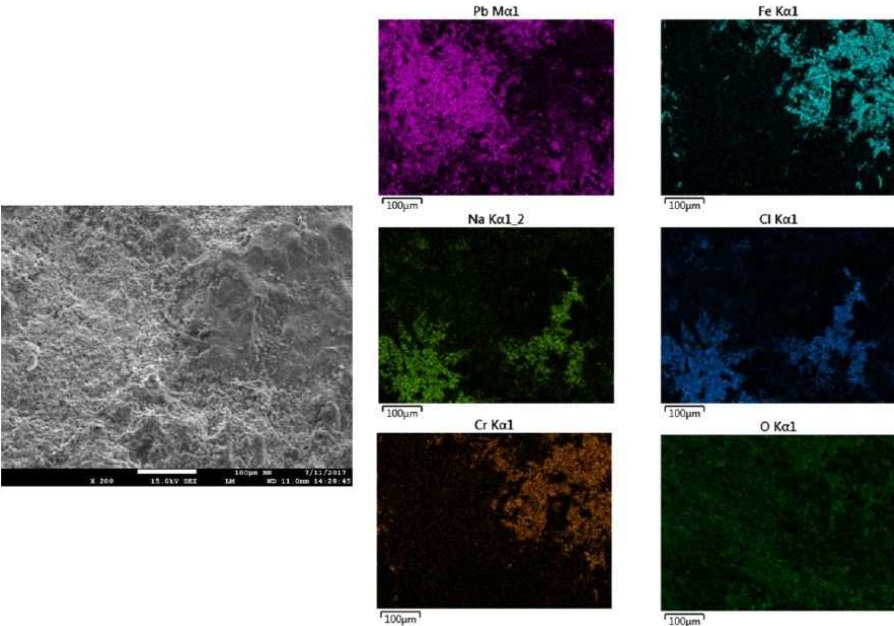
Figure 21 - Secondary electron image of white deposits and the EDX-map of Pb, Fe, Na, Cl, Cr and O.

With use of the EDX mapping technique the nature of the white deposits was determined. In figure 10 a secondary electron image of the white deposit on the fracture surface is shown. EDX mappings of Pb, Fe, Na, Cl, Cr and O are displayed. Traces of Si, Ca, C, Mg, Mo, Al and Ni were also found, but since they were present in very small amounts and were distributed more or less evenly over the surface, they were not shown. The mappings visualized the presence of lead oxides, PbO, on the fracture surface of the broken off keel bolt. Some parts of the investigated area were not covered with the PbO, but instead iron with passive Cr₂O₃, chromium oxide, on top was present. The presence of salt, NaCl, was also demonstrated.

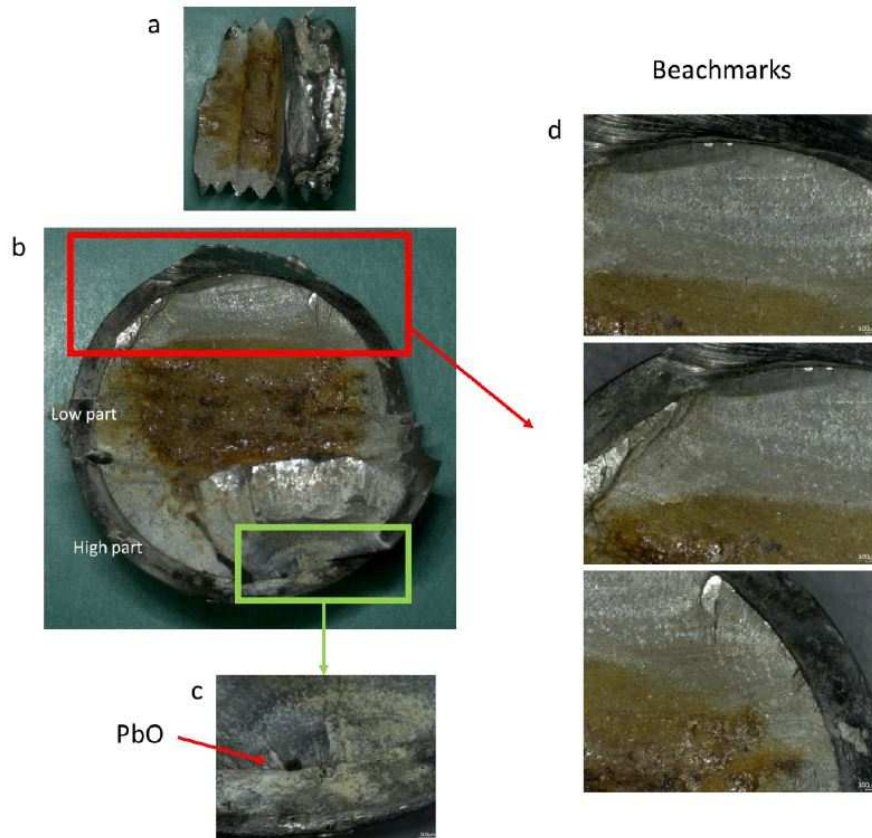
Figure 23 - Optical microscopy images of fracture surface of broken off keel bolt 5

Figure 23 shows the optical imaging of the fracture surface of broken off keel bolt 5. Attention was drawn to the important findings on this surface, delimited by the red and green boxes.

a) Side view b) Overview of fracture surface c) PbO deposits, high part fracture surface d) Beachmarks, low part fracture surface.

On the higher part of the fracture surface of the broken off keel bolt, PbO deposits were found and were verified by EDX, as well as a reflective surface similar to the reflective surfaces found on the fracture surfaces of broken off keel bolts 2 and 4. On the lower parts of the fracture surface of the broken off keel bolt 5, two zones can be determined. One zone consisted of corrosion products similar in composition to the corrosion products found on the fracture surface of broken off keel bolt 2, which indicated that this part of the bolt had been exposed in a saline environment, such as sea water, for some time.

The second zone was not corroded, nor did it exhibit a reflective appearance or PbO deposits on the surface.

This zone exhibited clear signs of a recognizable failure mode, i.e. fatigue. The lines visible on figure 12d and 13 were referred to as beachmarks¹⁰ and were an indication of failure by fatigue. Fatigue is a form of failure that occurs in structures subjected to dynamic and fluctuating stresses, after a lengthy period of repeated stress or strain cycling. Fatigue failure is characterized by three distinct steps. 1) crack initiation, 2) crack propagation, and 3) sudden final failure. Beachmarks are formed during the crack propagation step. They indicated that there were interruptions during the crack propagation stage. A possible explanation for the presence of the not corroded beachmarks, was that this part of the bolt was attached for a longer period of time to the counter part of the bolt compared to the corroded part.

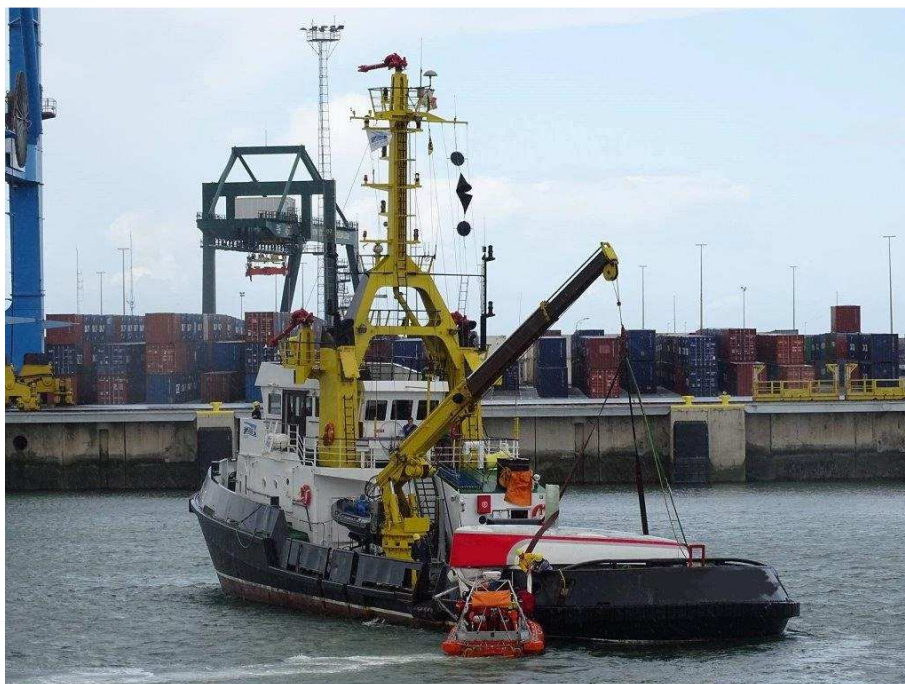
Figure 25 - Sailing yacht recovered off the Belgian coast after keel was lost

The yacht that had lost its keel, had reportedly grounded in the months prior to losing its keel.

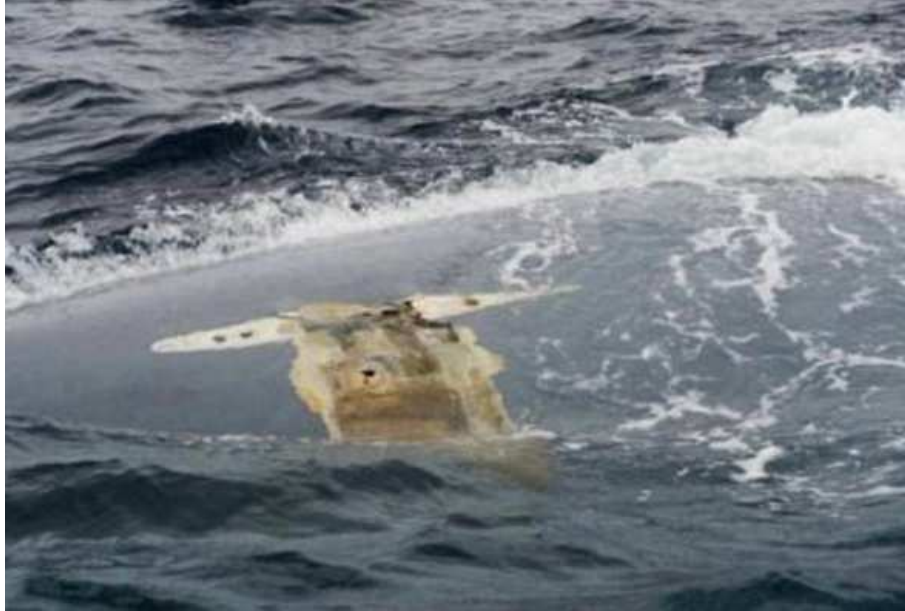
*Figure 26 - Derelict sailing vessel found in the Atlantic ocean
with keel missing*

There were no survivors. The hull was found adrift in upside down position, with the keel missing. An investigation into the cause of capsizing, by a marine accident investigation body, revealed that the vessel had capsized after having lost its keel and that the vessel had grounded in the past, without having the keel removed for inspection of the keel bolts, after it had grounded.

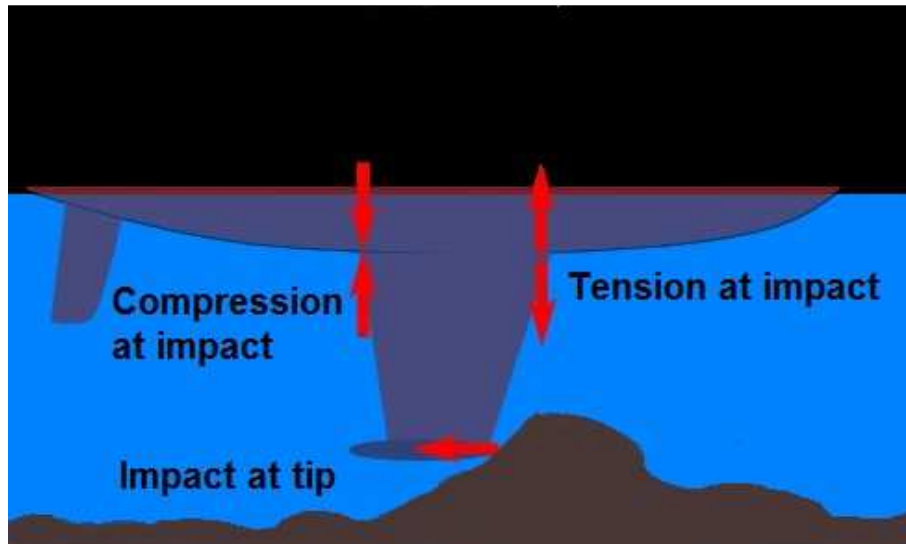
Figure 27 - Forces on keel bolts of sailing vessels during grounding

The tension at impact can be that severe that keel bolts break, in which case the broken off ends of the bolts could be observed from inside the sailing vessel when checking the pre-tension on the nuts.

In the case of the sy CAPELLA, with the keel bolts welded to the underside of the keel plate it was also not possible to assess the condition of the keel bolts by checking the pre-tension on the nuts holding the keel bolts in position inside the sy CAPELLA, since the way of fastening concealed the condition of the keel bolts below the welds on the bottom of the keel plate.
