Inadvertent Distress Beacon Activations

ORCV Special Investigations Group September 2022

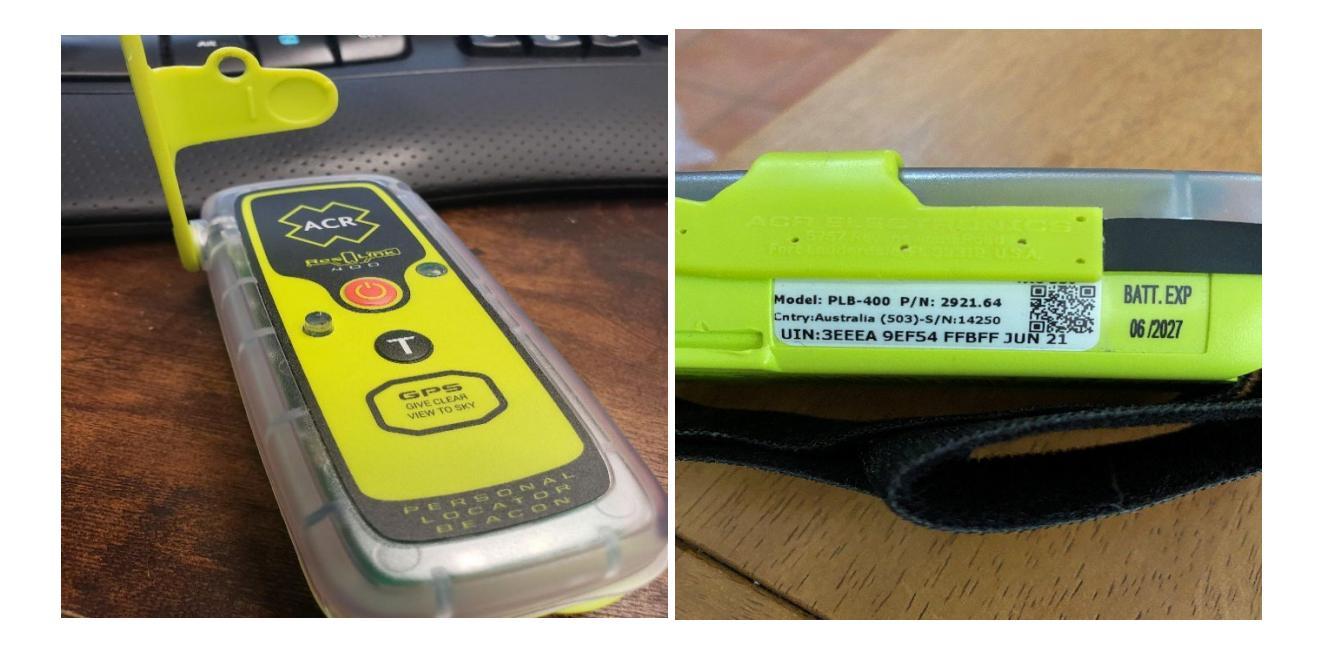
- 1. S/N 2535 FOR
- 2. S/N 14250 FOR

<u>Problem Statement</u>: BOTH UNITS INADVERTENT ACTIVATION DURING MELBOURNE TO HOBART RACE

Conclusion: There are no known defects associated with the units that experienced the inadvertent activations. All regulatory requirements were satisfied based upon the test conditions that were exercised at ACR. It is recommended that consumers review the user manual and understand proper operational conditions to limit the potential inadvertent operations that may be experienced with the unit (<u>PLB Tips Guide</u>). In addition, ACR has taken additional preventative measures that will be reflected in PLB product enhancements that limit inadvertent activations starting in 4Q2022. *See below*:

To introduce a new part to the PLB. A spacer that will be place between the front cover and the PCB in order to address inadvertent activations
