Inadvertent Distress Beacon Activations

ORCV Special Investigations Group September 2022

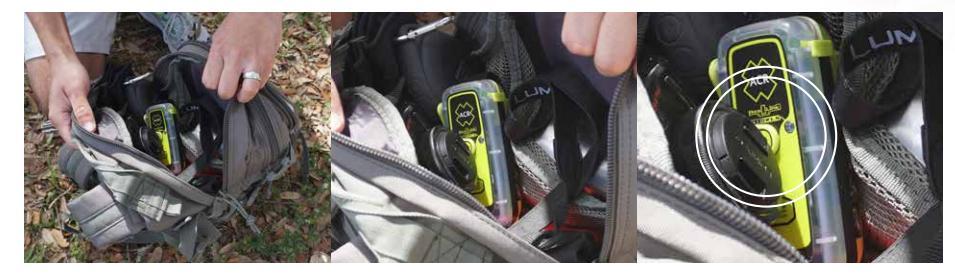
Don't Clustering & CRAMMING

Usually the normal behavior would be to drop whatever items into your backpack or sack, but this can lead to 'clusting or cramming' of items. This could put added strain on your valuables and also lead to a potential false activation.

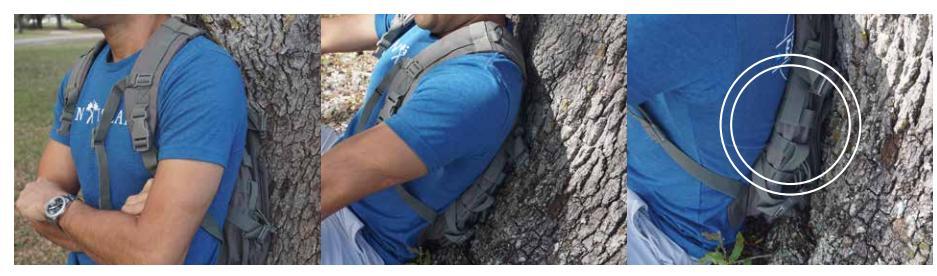
♥ CRUSHING & PRESSURE

A common occurrence on the trail or during other adventures is leaning on, or placing our weight on, our backpack. This scenario also creates strain on backpack contents and can potentially reduce the battery life of your PLB due to potential inadvertent activation.

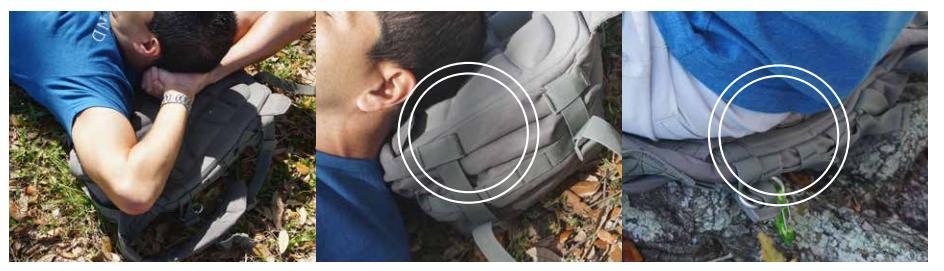
♥ RESTING & SITTING

Use of equipment as a cushion or pillow can seem practical on the journey, but be aware of the weight being placed on your valuables. Gives new meaning to the phrase; "Between a rock and a hard place".

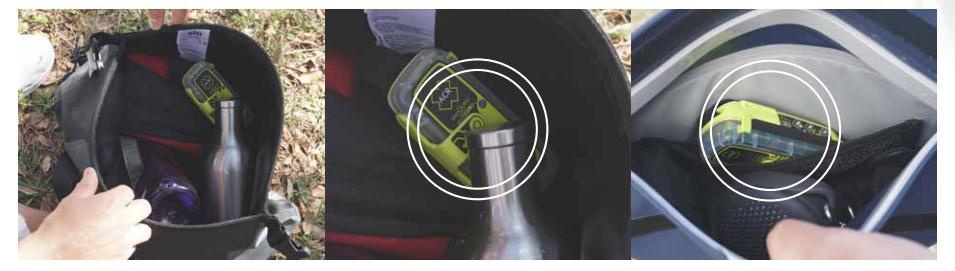
Don't Clustering & Cramming

Drybags, while protecting from water and dust, often offer little to no protection from impact or shock. Be conscious of other items also being stored as these can potentially impact your beacon and other valuable devices.

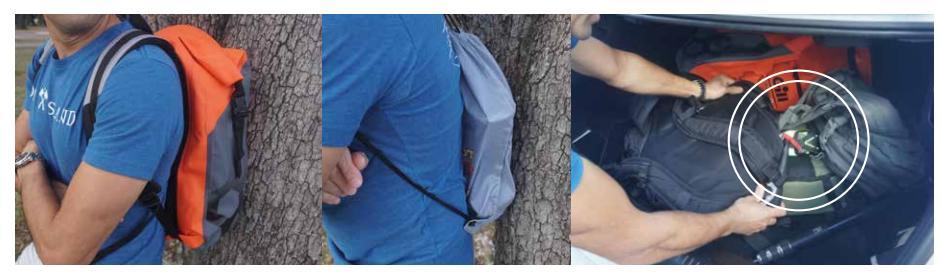
😳 CRUSHING & PRESSURE

Pressure and weight are even more important with these types of storage options as they often don't have any kind of foam or cushion. Also be aware of loosely storing your beacon in crowded compartments within your vehicle/vessel.

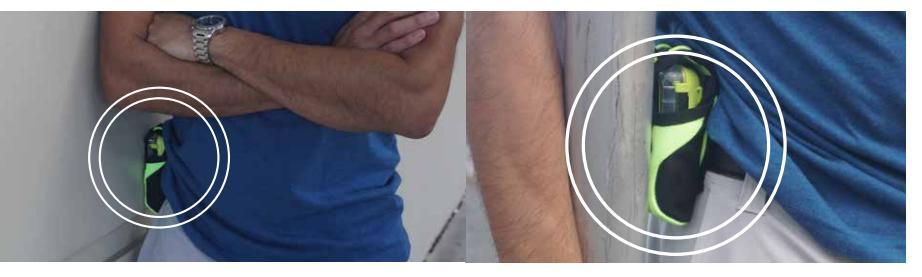
♥ RESTING & SITTING

With pouches, be aware of the environment around you. Remain cognizant of your posture when leaning, sitting, or resting to negate the possibility of an accidental activation.

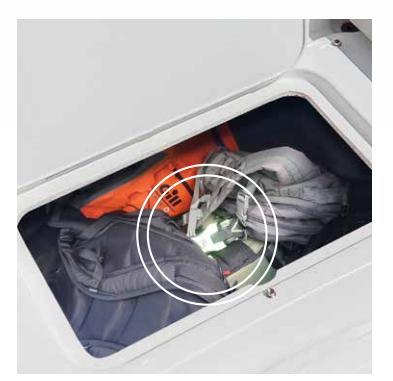
Don't Clustering & CRAMMING

Providing ample space and not simply dropping your beacon into tight and highly compressed environments can provide for situation where a false activation can occur.

Please avoid cramming or cluttered storage compartments.

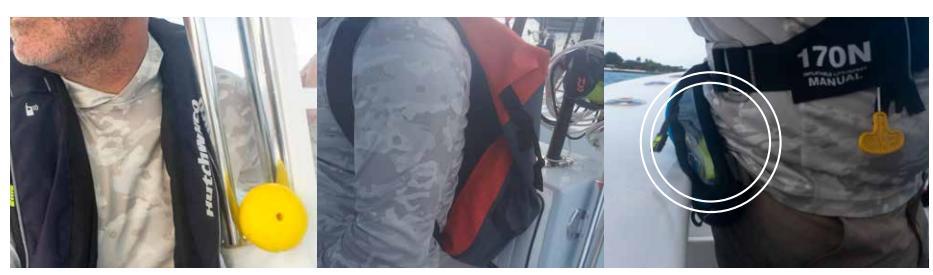
♥ CRUSHING & PRESSURE

Leaning or placing weight on your equipment could inadvertently damage or tamper the placement of your beacon. Such as your life jacket deployment, for example.
