Report on the investigation of
the loss of the yacht
Cheeki Rafiki
and its four crew
in the Atlantic Ocean,
approximately 720 miles east-south-east of
Nova Scotia, Canada
on 16 May 2014

At about 0400 on 16 May 2014 the UK registered yacht *Cheeki Rafiki* capsized approximately 720 miles east-south-east of Nova Scotia, Canada while on passage from Antigua to Southampton, UK. Despite an extensive search that found the upturned hull of the yacht, the four crew remain missing.

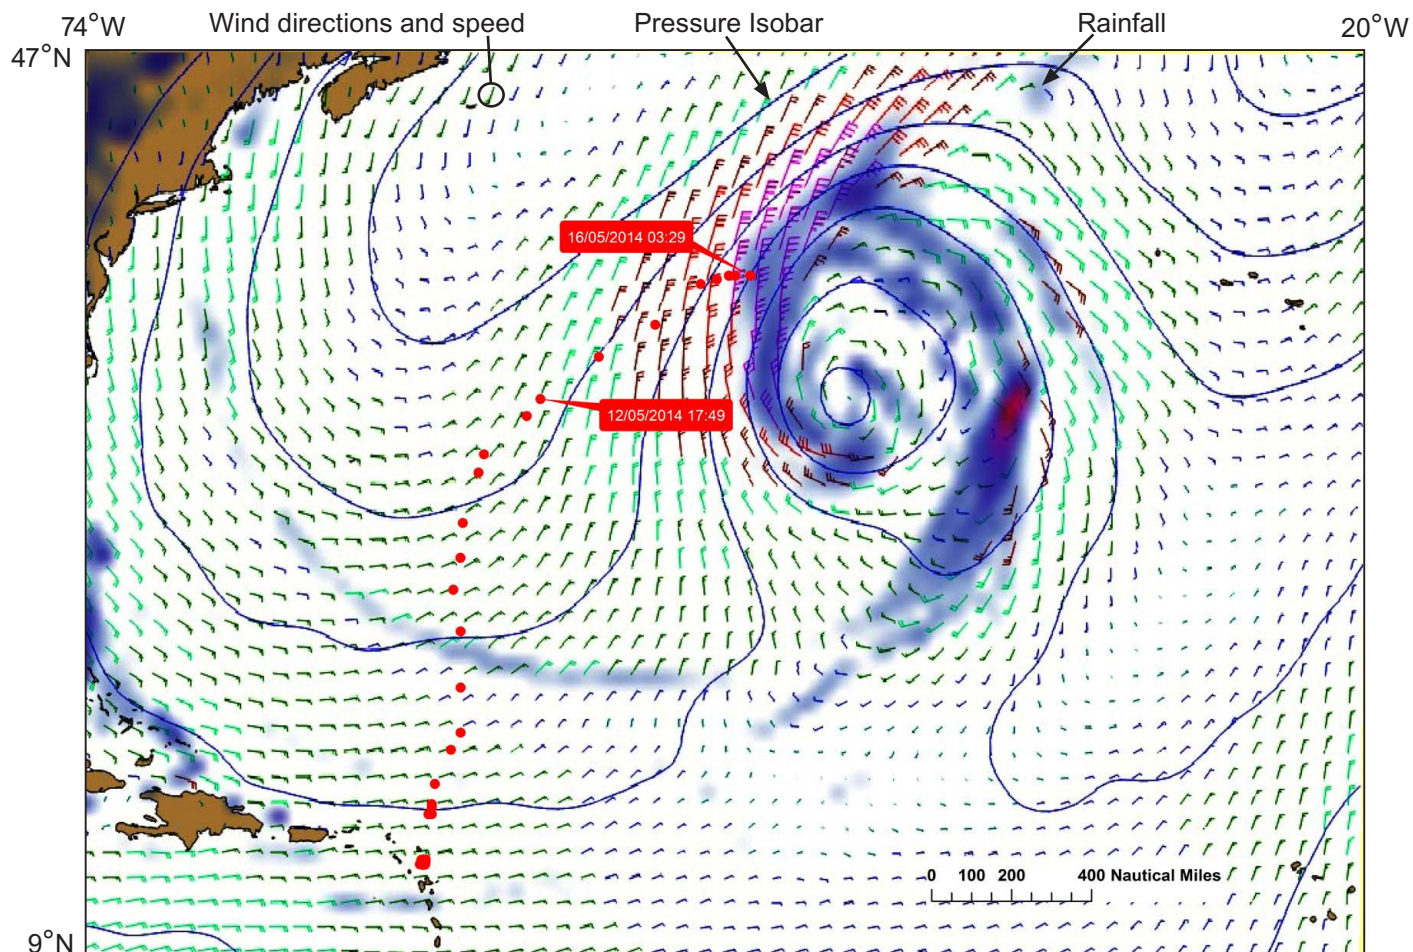
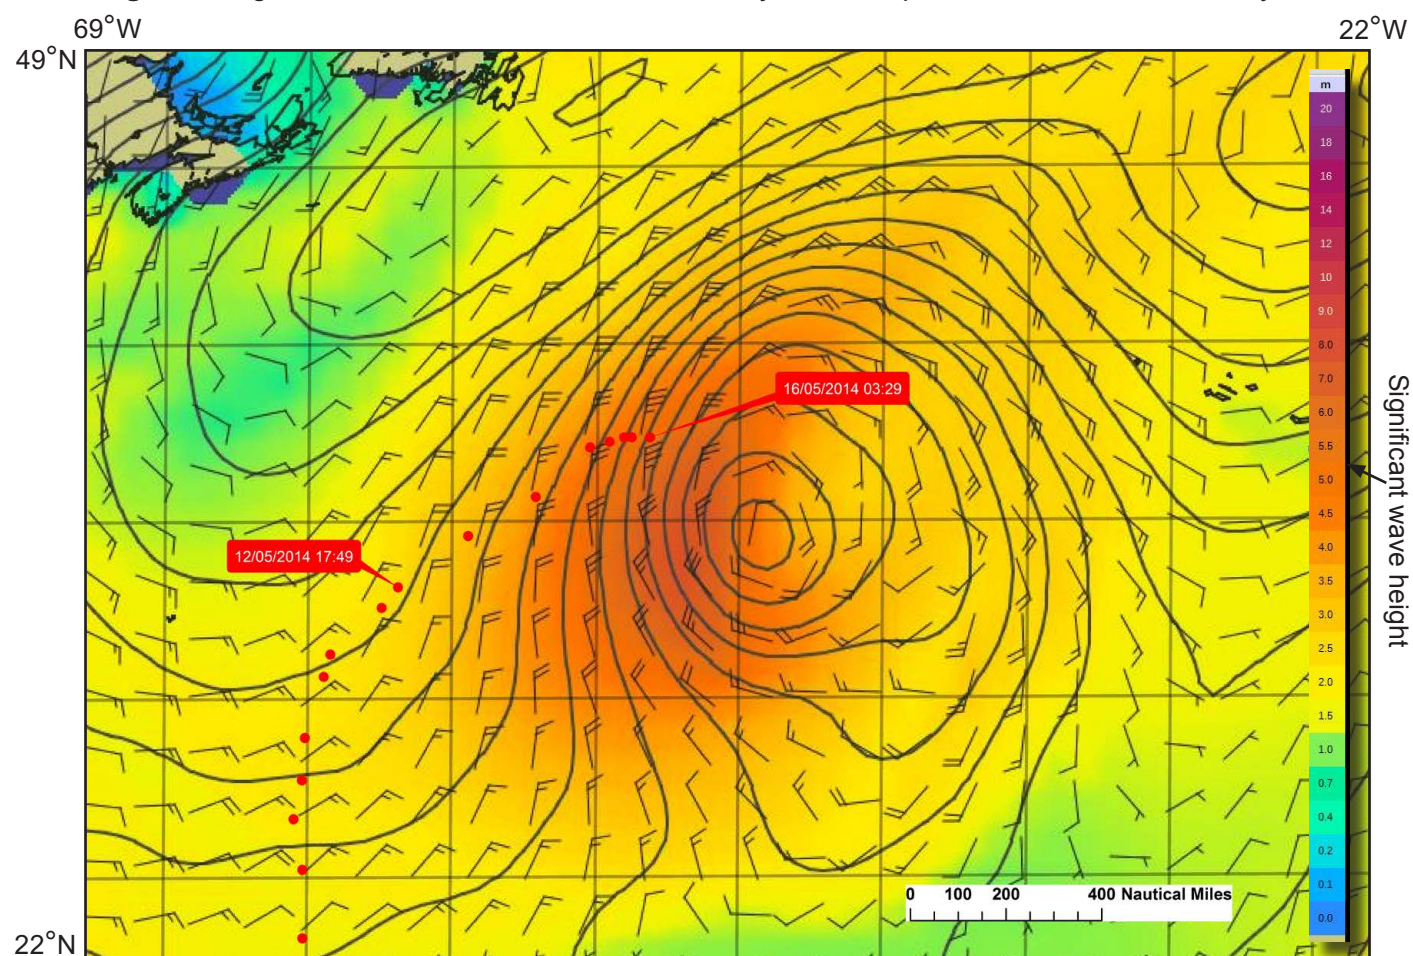
Figure 4: Ugrib forecast conditions for 0300 16 May 2014, as predicted at 0600 on 12 May 2014

In his email of Saturday 10 May the skipper reported having to use the engine the previous night due to light winds, and when the principal/director replied to that email on Monday 12 May he advised the skipper to '*perhaps steer NE*'. The principal/director's email mentioned that there would be lightish winds until Wednesday, but did not warn of the worsening conditions thereafter (see **Figures 4** and **5**) that were predicted in the Ugrib 12 May 0600 forecast.

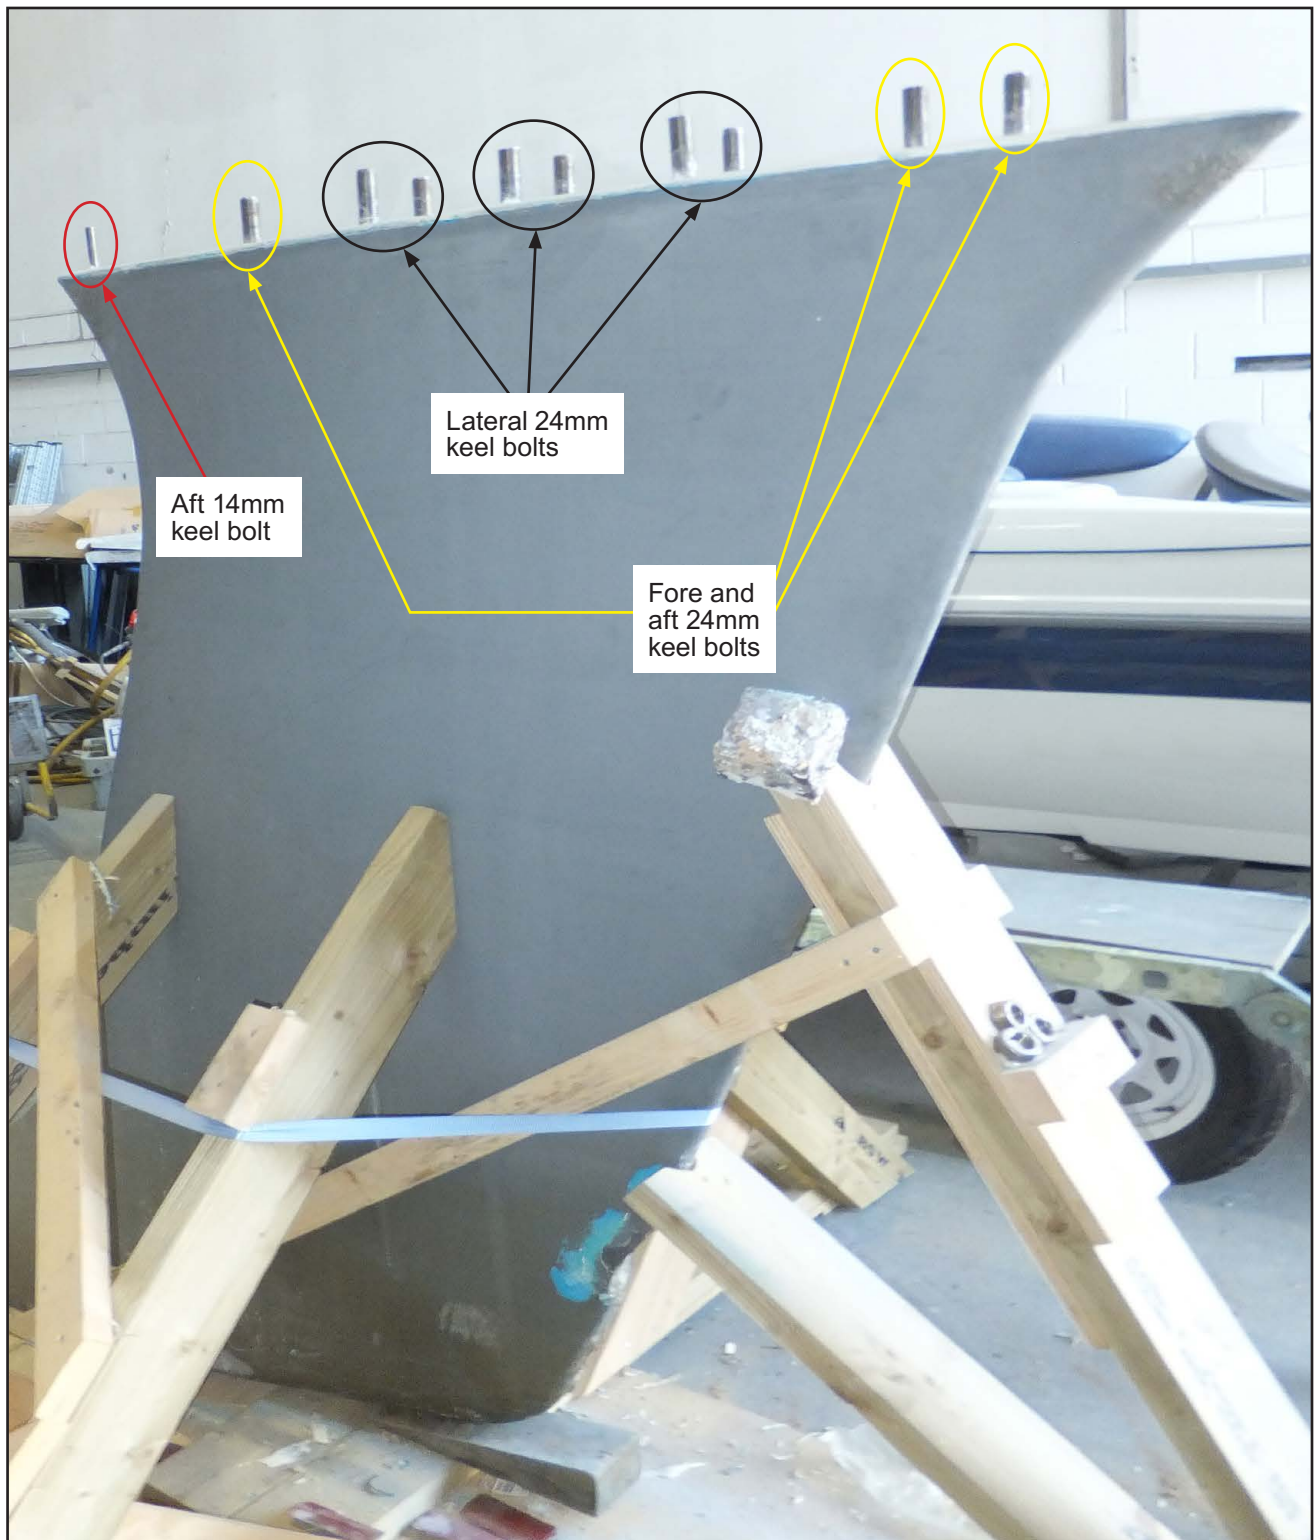
Figure 9: Typical Beneteau First 40.7 keel bolt arrangement (not *Cheeki Rafiki*)

The Beneteau First 40.7 was available with two keel options: a shorter cast iron bulb type keel and a more popular deep fin cast lead keel. The lead keel was manufactured with stainless steel bolts cast into it. There were nine 24mm bolts: three designed to carry the fore and aft loading on the keel, and six primarily to carry the lateral loading (**Figure 9**). The three bolts carrying the fore and aft loading were arranged with two single bolts at the forward end of the keel and one single bolt aft. The six bolts designed to carry the lateral loading were arranged in pairs. All of the 24mm bolts were secured to the glass reinforced plastic (GRP) hull with a washer (i.e. backing) plate and nut (**Figure 10**).

In addition, the design provided for a 14mm bolt at the extreme forward end and at the after end of the keel, to prevent the GRP flexing away from the top of the keel. However, only the aft bolt was installed in the manufactured product owing to insufficient material being available in which to effectively install the forward bolt (**Figure 9**). The Wolfson Unit's assessment of the keel structure (**Annex C**) was based on a Beneteau First 40.7 design incorporating only the aft 14mm bolt.

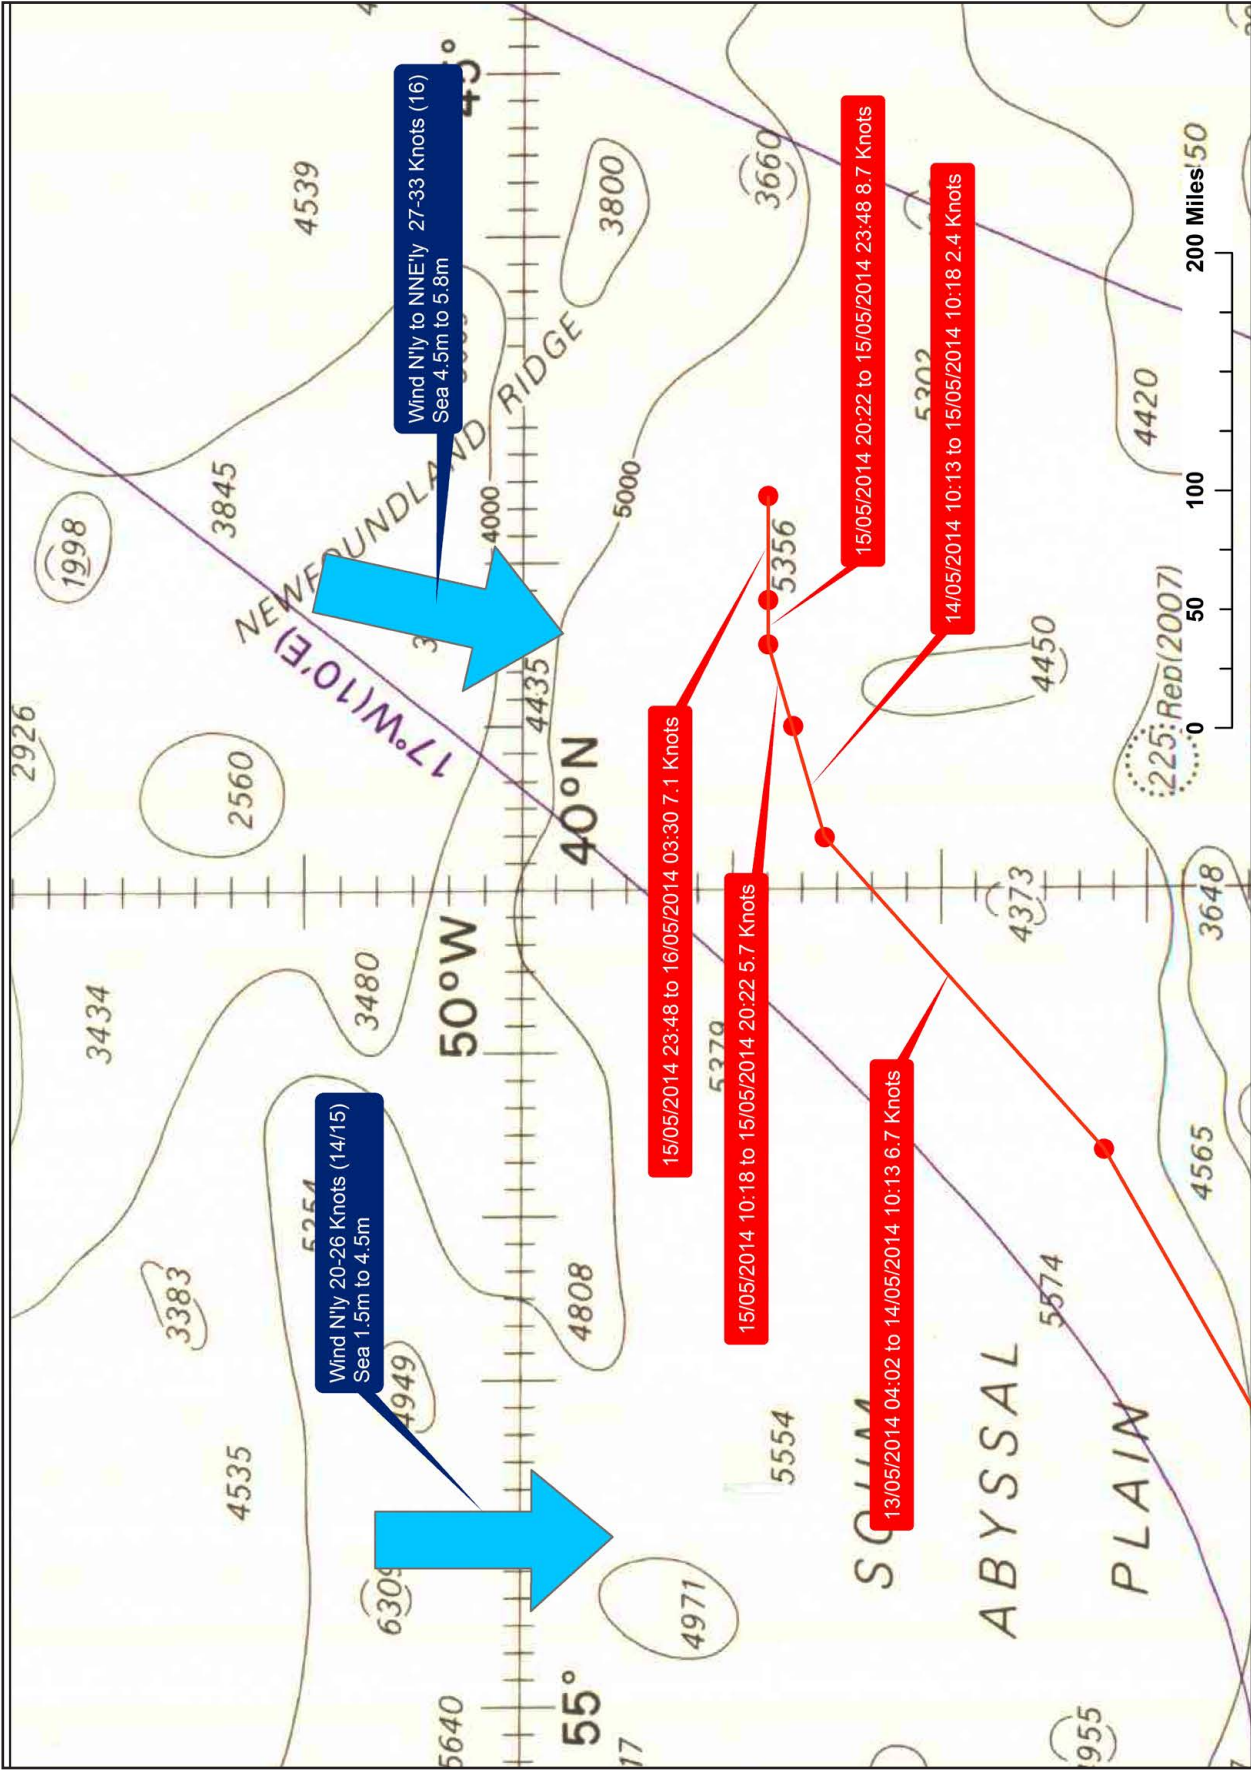
Figure 20: Cheeki Rafiki's indicative courses and speeds made good obtained from its Iridium satellite telephone recorded positional data between 14 May and 16 May 2014

Without the benefit of the principal/director's advice, it is possible that the skipper had neither identified nor considered that the source of water ingress was in the keel area. Consequently, it is probable that he had neither recognised the increasing risk of the keel becoming detached nor the danger of continuing on the same approximate course without reducing speed (**Figure 20**), producing high lateral keel load; a point not included in the principal/director's advice.
