Report on the investigation of
a fatal man overboard from the Reflex 38 yacht
Lion

14.5 miles south of Selsey Bill, West Sussex

18 June 2011

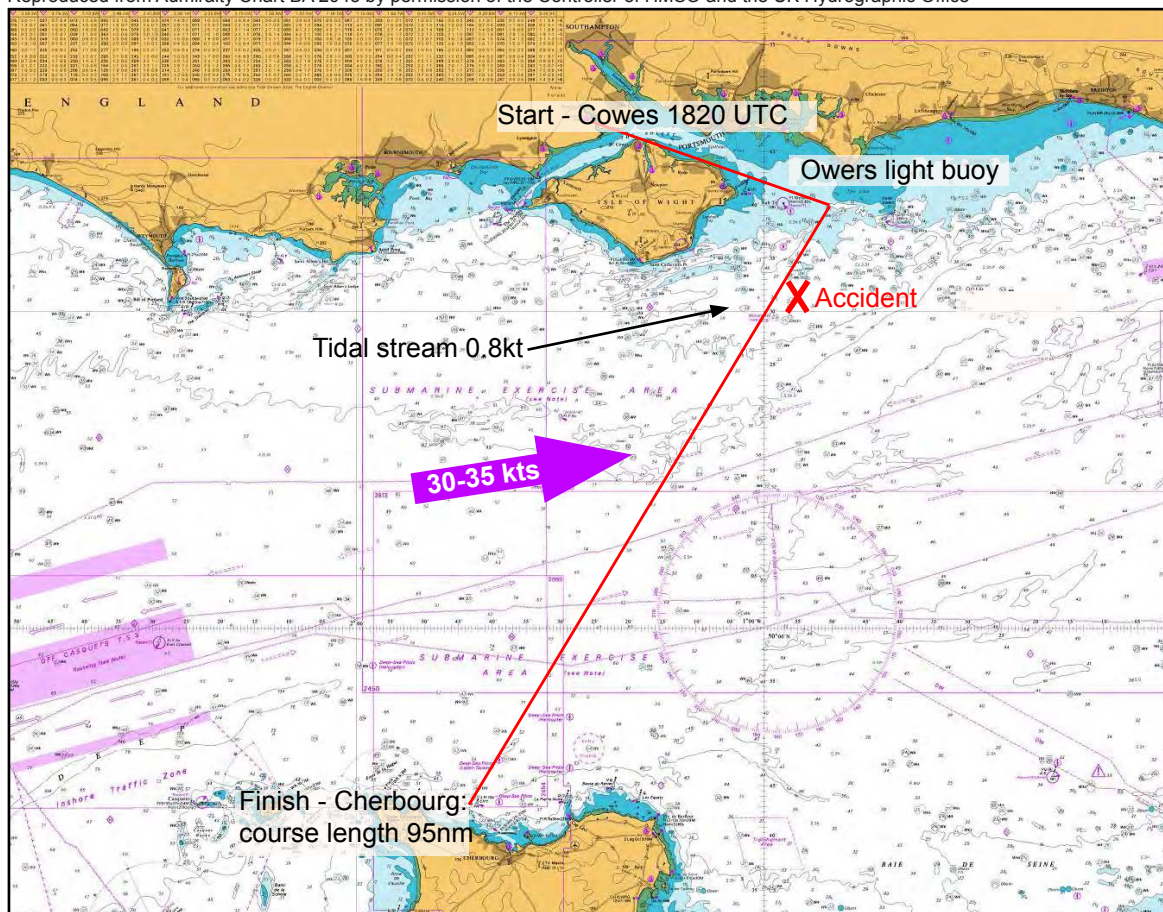
Figure 1: Chartlet showing Morgan Cup Race course and key events

At 1320 on 17 June, RORC's Race Committee sent details of the Morgan Cup Race course to the competitors by e-mail (**Annex C**). The course, at 95 miles long, was relatively short to take account of the difficult conditions expected. A chartlet showing the course is at **Figure 1**.

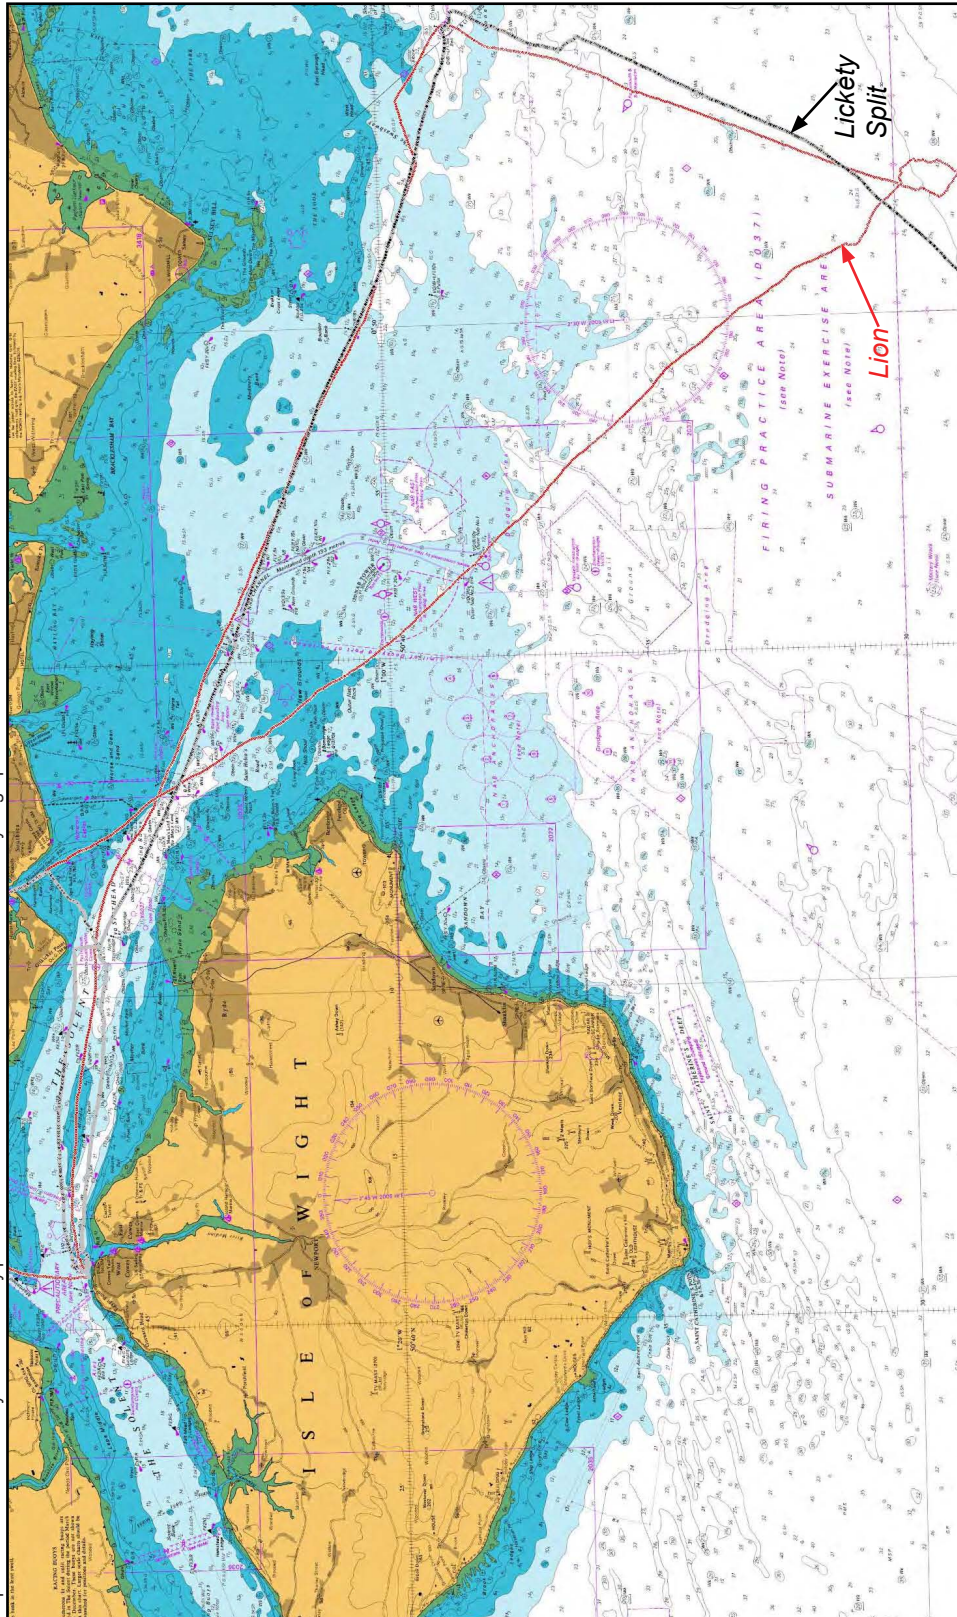
Figure 2: Chartlet showing AIS/GPS tracks for *Lion* and *Lickety Split*

The early stages of *Lion*’s race were uneventful as the yacht progressed east along The Solent close-hauled at speeds over the ground (SOG) of between 6.4 and 8 knots (**Figure 2**). At about 2025, the helmsman felt that with the No.3 genoa the boat was under-powered. The skipper agreed, and the sail was replaced with the No.2 genoa; the No.3 genoa was then taken into the cabin for repairs to the luff.

Lion's combined Automatic Identification System (AIS) and GPS tracks up to the accident and the return leg to Portsmouth are at **Figure 2**. The figure also shows the AIS track for *Lickety Split*.

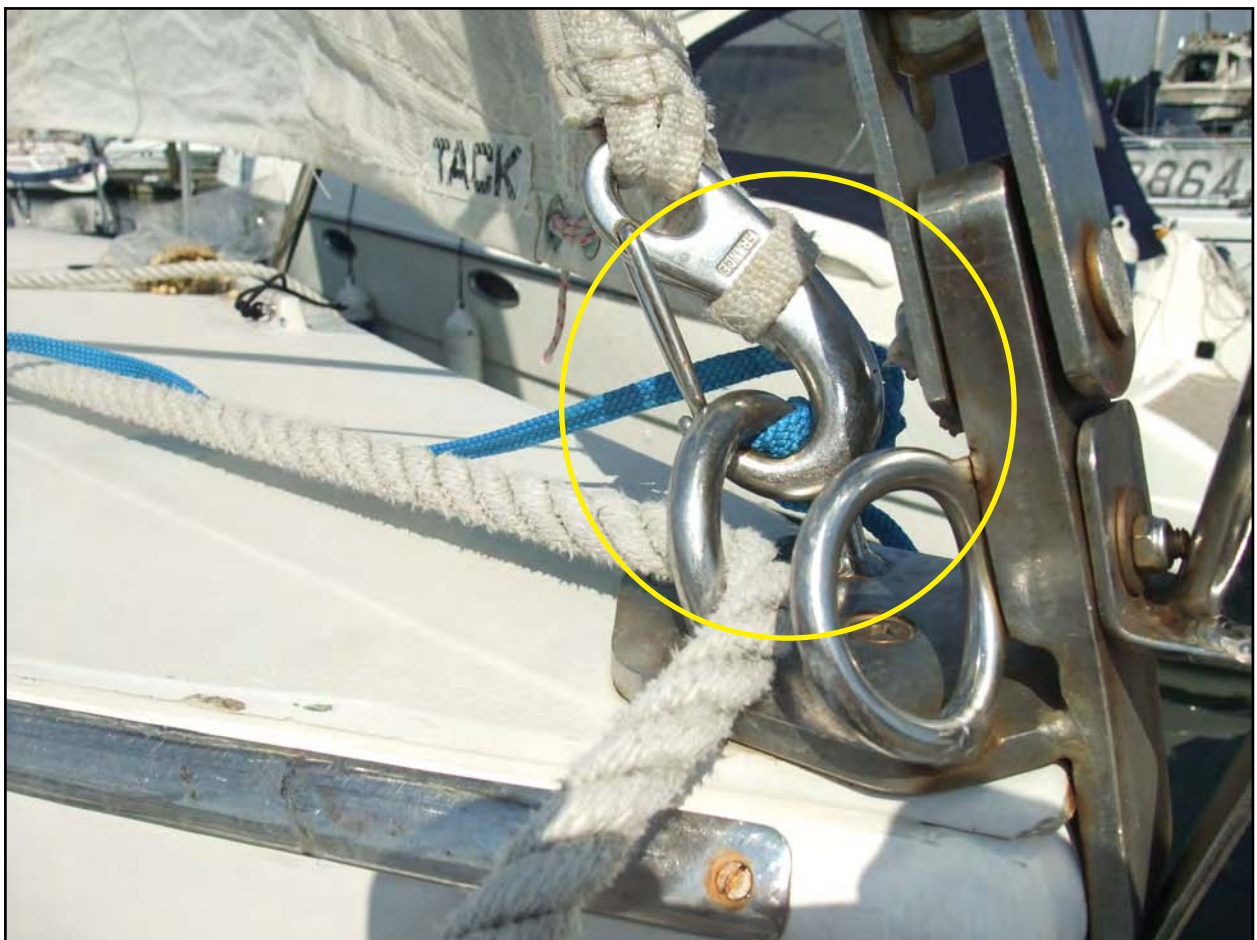
Figure 4: Genoa tack connected to the forward pad eye

The helmsman then heard the skipper instruct the bow and mast men to lash the No.1 genoa on the deck. The sail was secured to the port guard wires and supporting stanchions using light “bungy” straps and two sail ties (**Figure 3**) while the tack remained clipped to the forward pad eye (**Figure 4**). Soon afterwards the helmsman instructed that the first reef in the mainsail should be taken in. Once the mainsail had been reefed, the skipper told the helmsman that he was content with the new sail configuration.

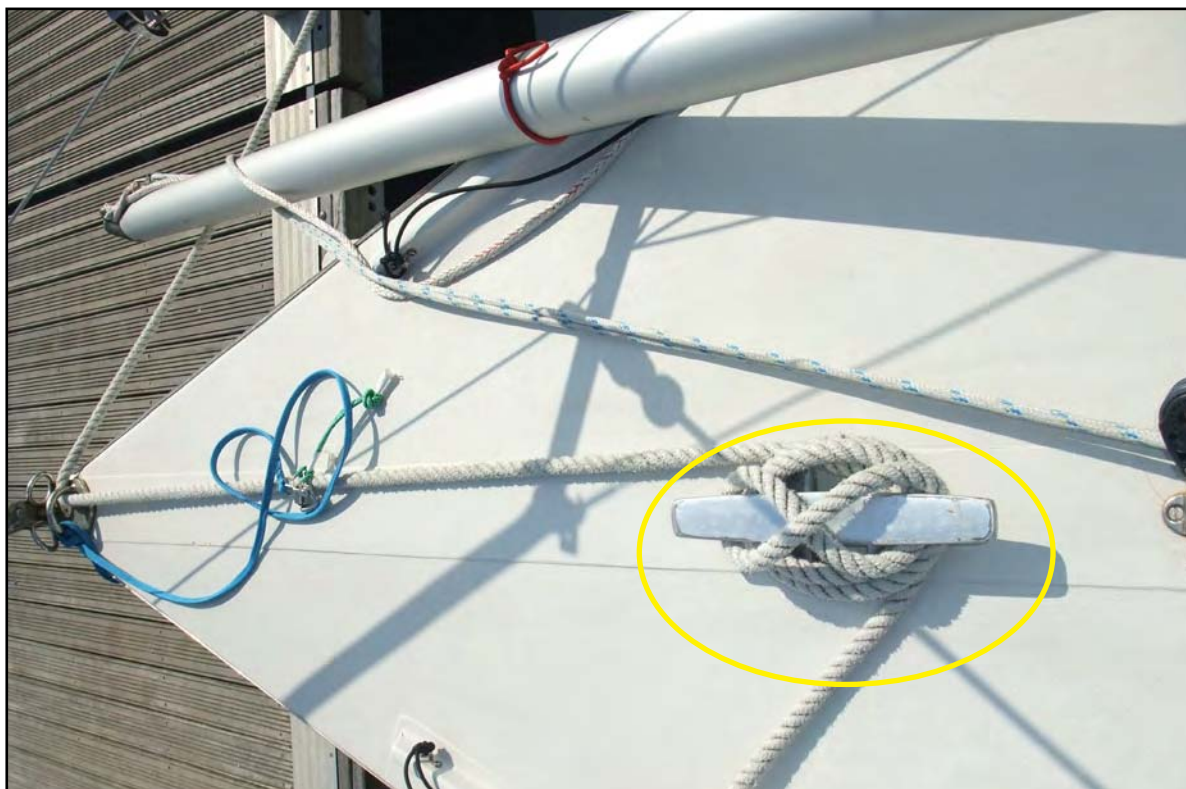
Figure 5: Position of the forward centreline cleat

As the skipper recovered the sail from the water it was passed along the starboard side by trimmers 1 and 2, and the navigator guided it down the companionway and into the cabin. When all of the sail was recovered on board, the skipper disconnected the tack from the forward pad eye. He then transferred his tether from the port to the starboard jackline in preparation to return to the cockpit along the high, starboard side, as was his usual practice. Almost immediately, the sail snagged and the skipper called “stop”. Trimmer 1 then saw him lie on the deck, on his stomach, facing forward and to starboard of the centreline. It is likely that the sail had snagged on the forward centreline cleat (**Figure 5**) and the skipper was attempting to free it. After a short time, the skipper called “OK” and the sail continued to be passed along the starboard side, partly over the coach roof and down the companionway into the cabin.

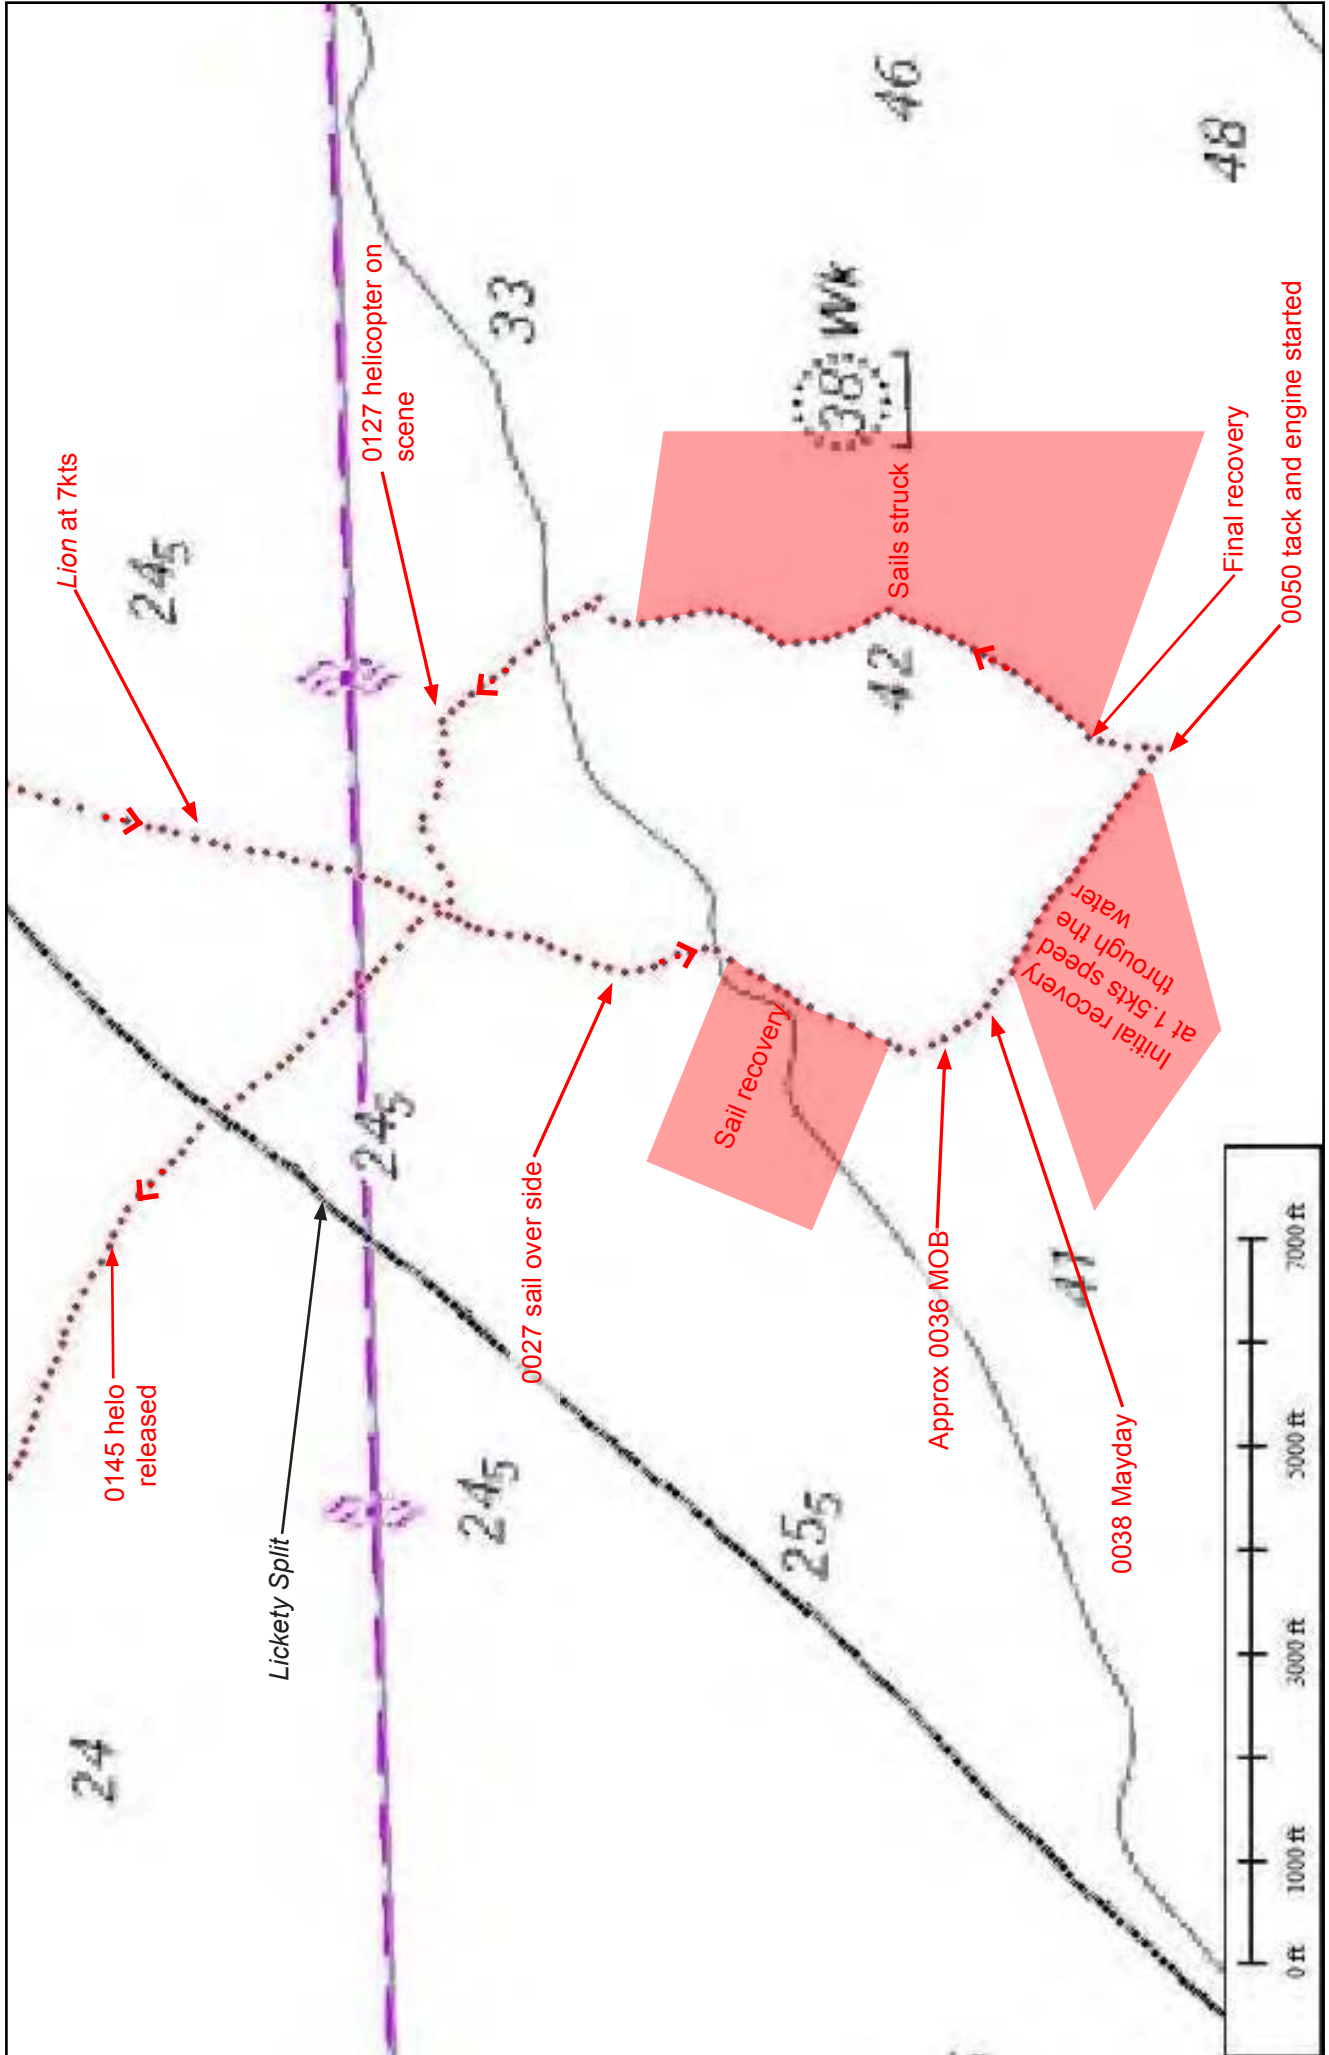
Figure 6: Detailed AIS track showing key events

To assist in the recovery, the helmsman instructed the general duties man to release the mainsheet, which had the effect of immediately slowing *Lion* down from 4.5 knots to 1.5 knots through the water, with a course over ground (COG) of approximately 135° True (T) (**Figure 6**).

A more detailed AIS track for *Lion*, showing the specific stages of the accident and actions taken, is at **Figure 6**.

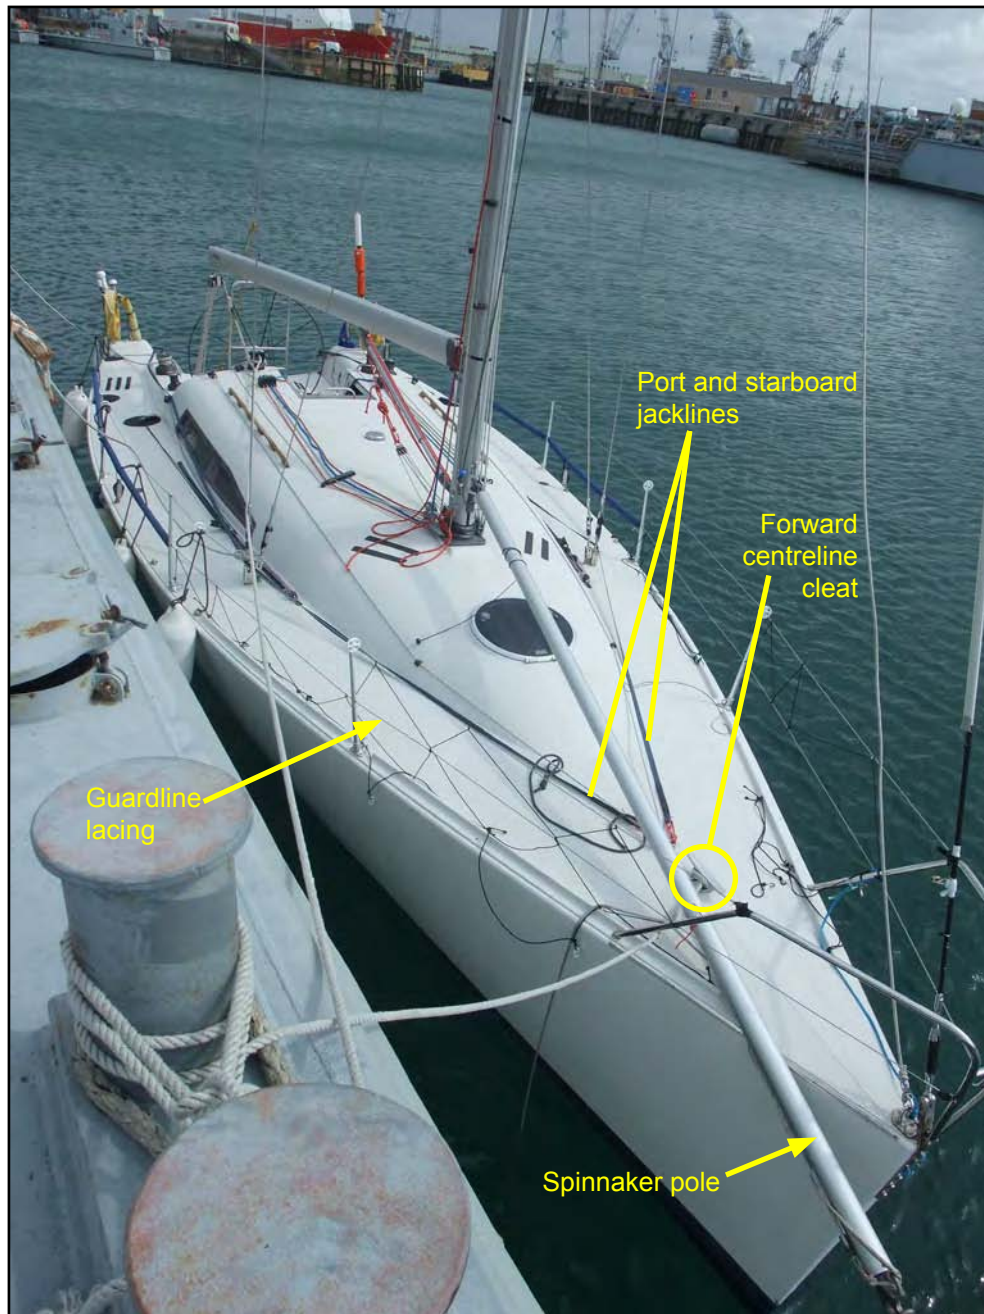
Figure 9: Deck layout

The port and starboard webbing jacklines were individually secured to the transom aft and to a forward common deck fitting positioned just aft of the cleat on the foredeck. On inspection, following the accident, the jacklines and fastenings were found to be in good condition.

The deck layout is shown at **Figure 9**.

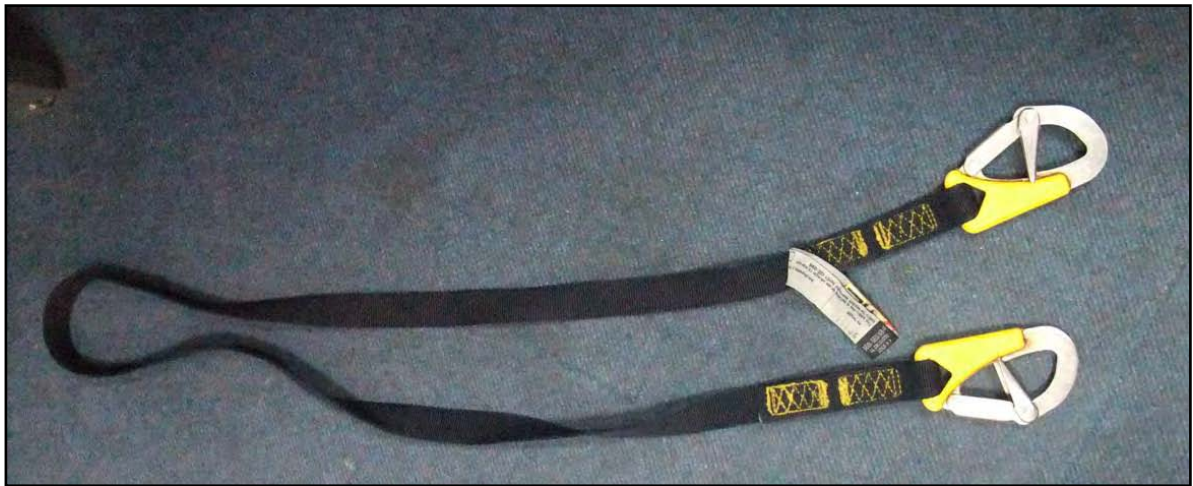
Figure 14: Two-hook tether

There are two main types of tether: the two-hook and the three-hook versions. The three-hook tether has an additional, short tether, complete with hook, stitched to the main tether at approximately the mid-point. The configurations are at **Figures 14** and **15** respectively.
