MARINE ACCIDENT INVESTIGATION BRANCH

FLYER TO THE YACHT DESIGN, BUILDING AND REPAIR INDUSTRY

MAX FUN 35 YACHT *Hooligan V*: KEEL DETACHMENT, CAPSIZE AND LOSS OF ONE CREW

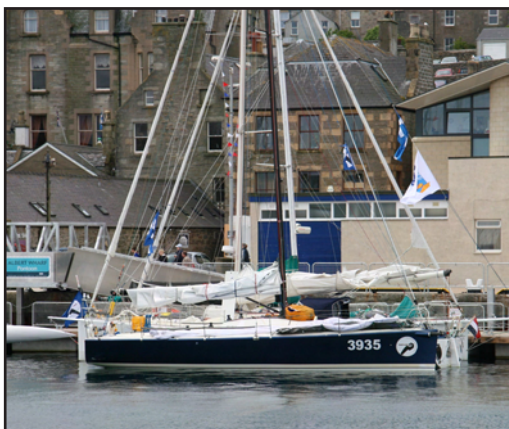
Before the mainsail could be reefed, the list rapidly increased, and at about 0320 the boat very quickly inverted, trapping the skipper inside the cabin. Once in the water, three of the crew found their way to the transom and immediately noticed that the keel was missing. As they set about cutting the liferaft lashings, the skipper managed to push the flare box and grab bag out of the cabin. These floated to the surface and the flares were set off. At the third attempt, the skipper escaped from the cabin, but there was no sign of the fourth crew member.
