ATSB TRANSPORT SAFETY REPORT
Marine Occurrence Investigation No. 268
MO-2009-008
Final

Independent investigation into the collision between
the Australian registered yacht

Ella's Pink Lady

Silver Yang

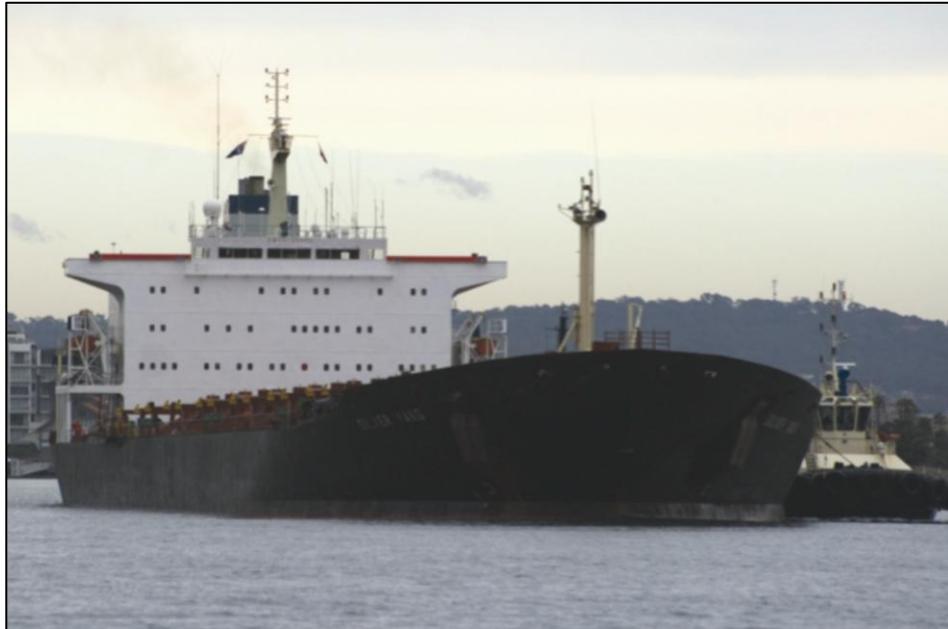
Figure 1: *Silver Yang*

Silver Yang is a conventional „Panamax“³ bulk carrier with seven cargo holds located forward of the ship’s accommodation superstructure (Figure 1). The ship was built in 1982 in Copenhagen, Denmark. It has an overall length of 225.03 m, a moulded breadth of 32.31 m, a moulded depth of 18.01 m and a deadweight of 63,800 t at its summer draught of 13.08 m.

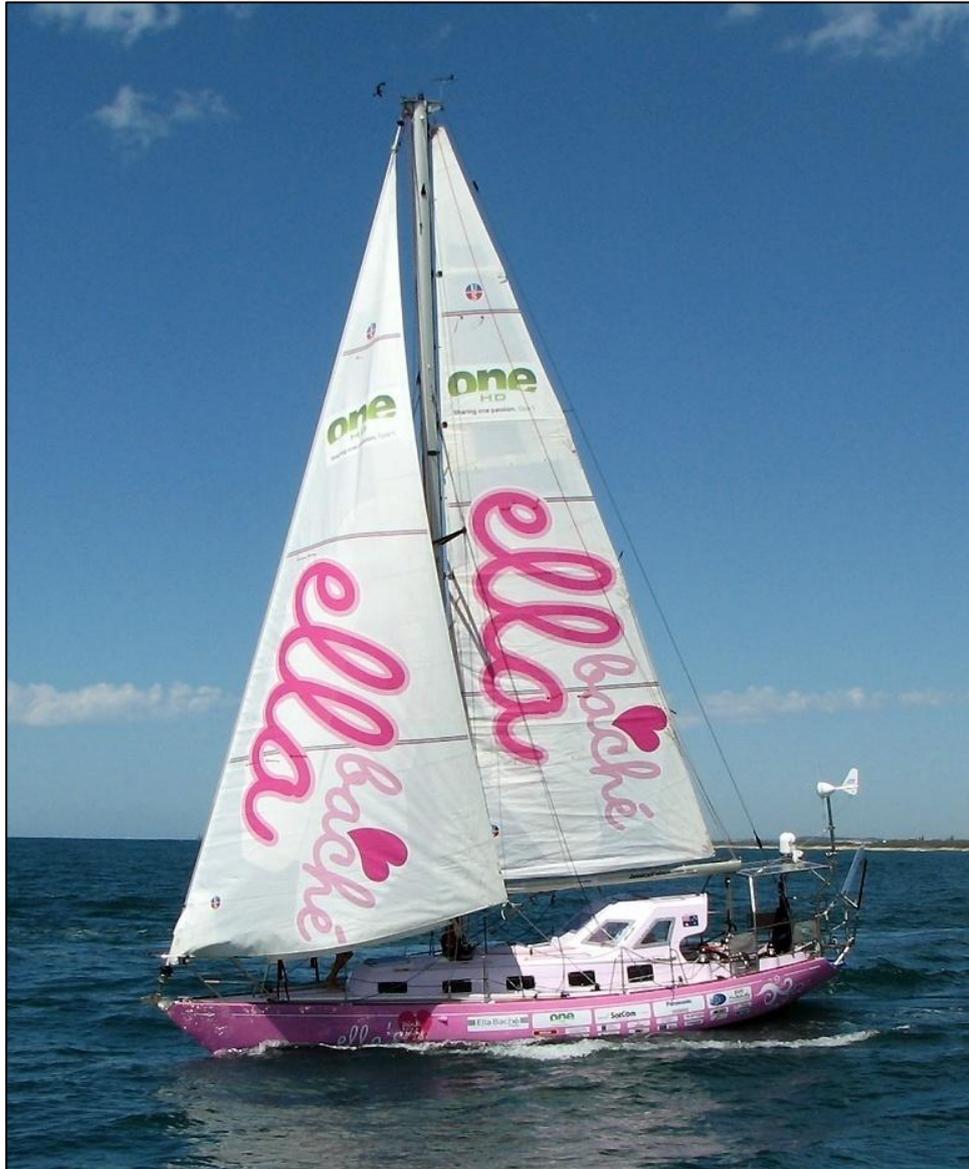
Figure 2: *Ella's Pink Lady*

At the time of the incident, the yacht was privately owned and registered under the name *McIntyre Adventure*. It had been loaned to its current skipper to enable her to attempt an unassisted, solo, round-the-world voyage. During the previous year, the yacht had undergone an extensive refit and re-named *Ella's Pink Lady* (Figure 2).

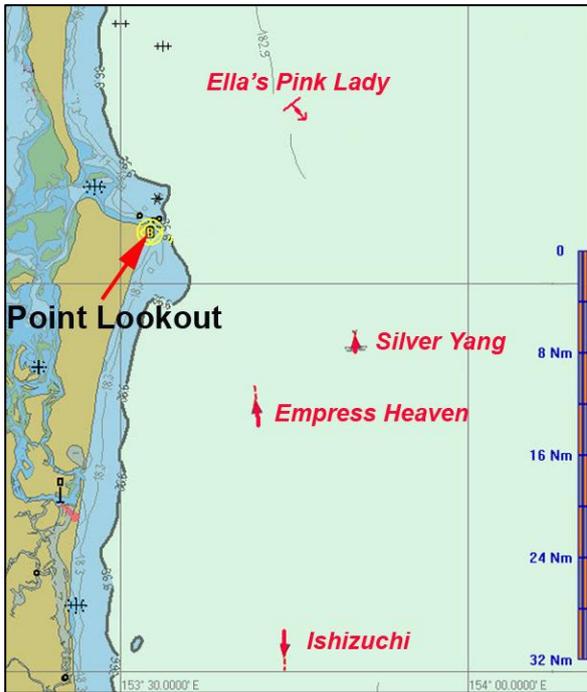
By 0030 on 9 September, *Ella's Pink Lady* was about 15 miles northeast of Point Lookout (Figure 3) and making good a course of about 140°(T) at a speed of 4 knots. The yacht was near the 100 fathom¹⁰ line and in the south-setting East Australia Current. *Silver Yang* was about 17 miles east-southeast of Point Lookout, on a northerly heading and travelling at a speed of 8.7 knots.

Figure 3: AIS image derived from the Point Lookout AIS base station showing the vessels in the vicinity at 0030

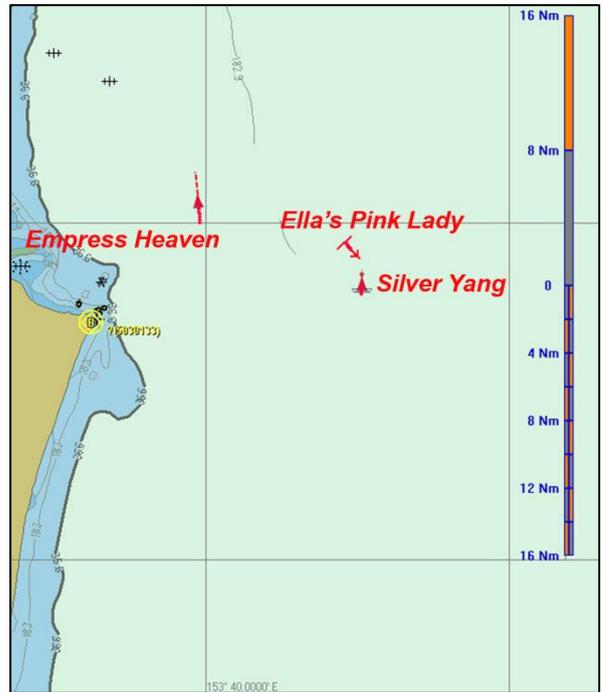
At about 0146, *Ella's Pink Lady's* skipper prepared for another catnap. The yacht was now making good a course of 144°(T) at a speed of 6.8 knots. The skipper checked the radar and noted that there was a vessel about 6 miles off the starboard quarter¹¹ (Figure 4). She could not see it visually, but she monitored its progress on the radar for about 1 minute. Once she had determined that it did not present a collision risk, she again set the radar guard-rings and alarm clocks before going to bed. By this time, *Silver Yang* was about 1 mile to the south-southeast of *Ella's Pink Lady's* position (Figure 5). However, the yacht's skipper had not detected the ship's presence.

Figure 4: AIS image derived from the Point Lookout AIS base station showing the vessels in the vicinity at 0146
